Pocket Safety Guide for Dams and Impoundments

FEMA P-911 / October 2016

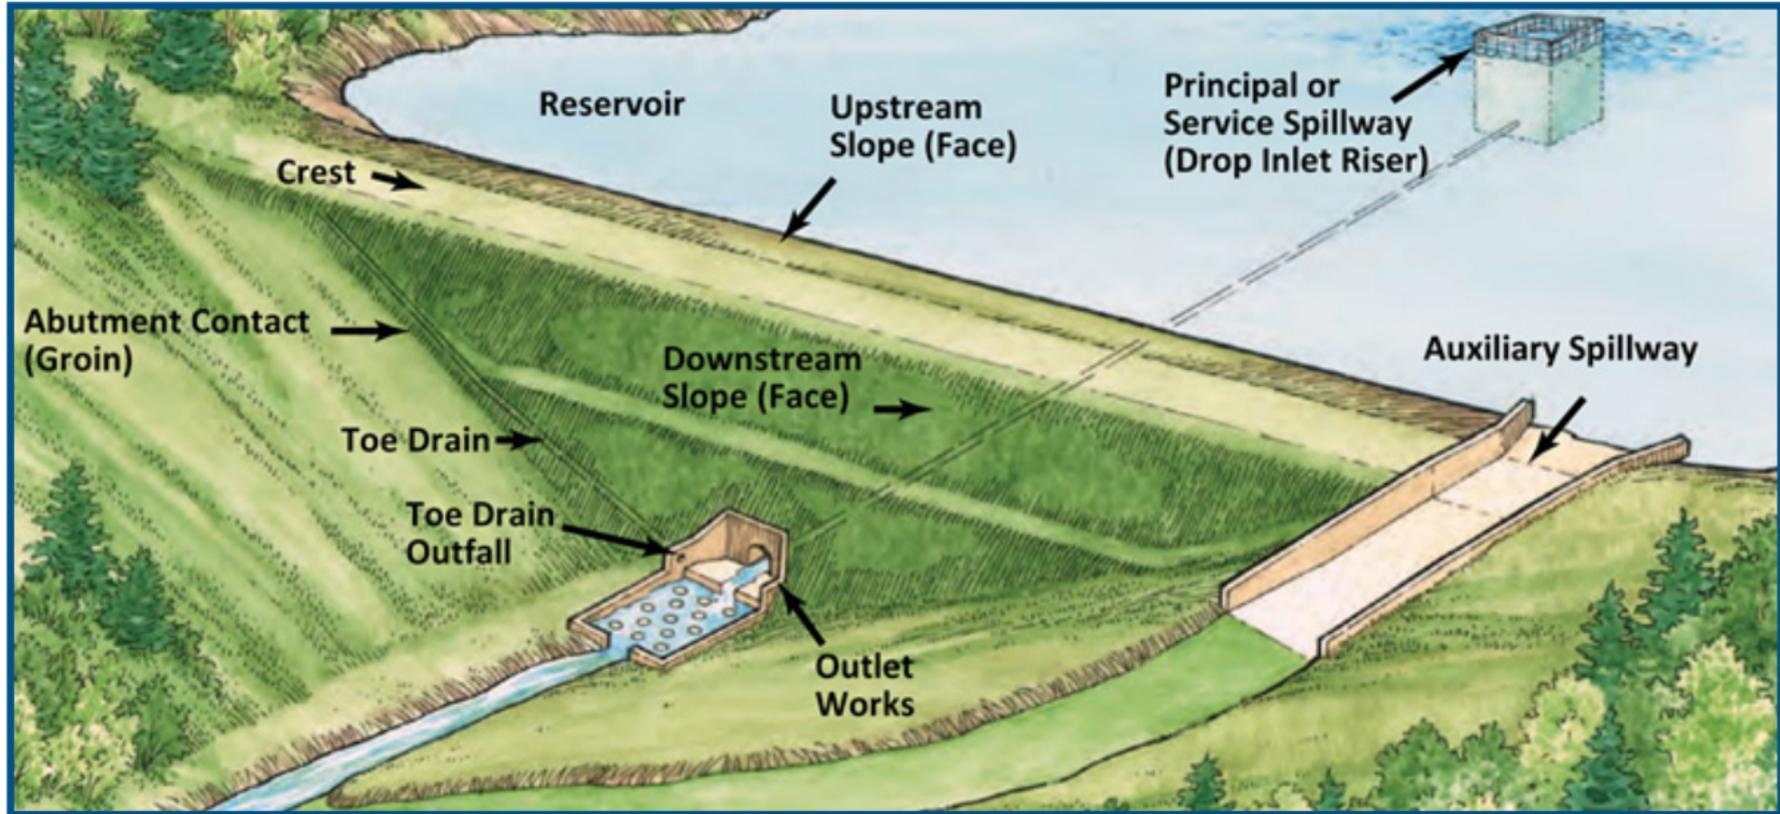
Figure 1 – Typical dam diagram showing common terms.

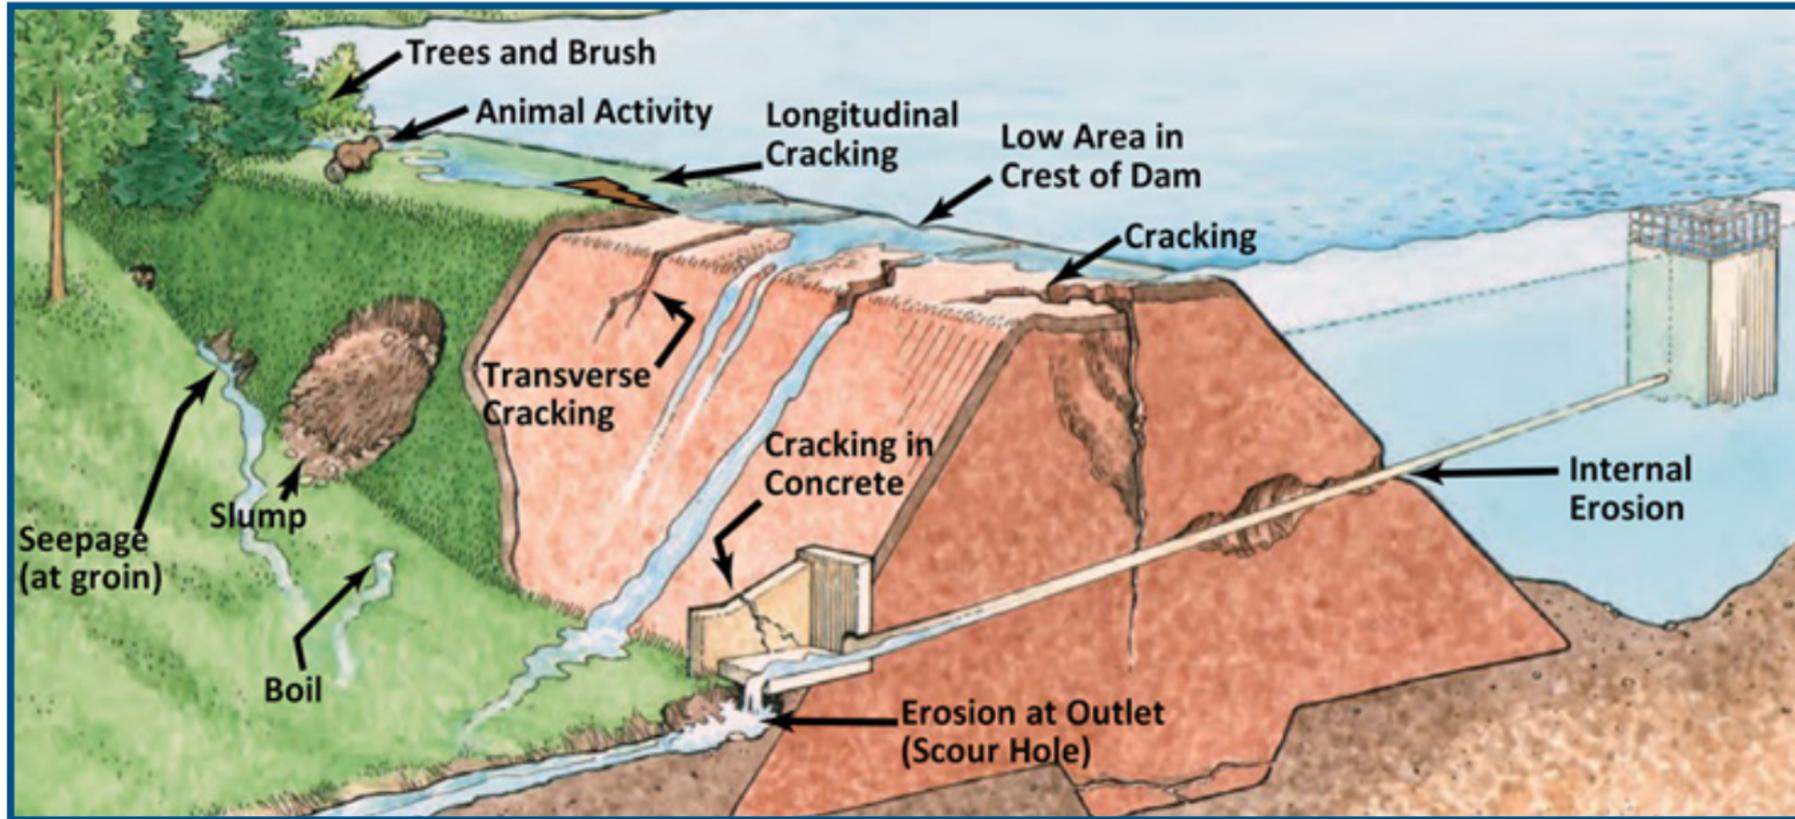
Figure 2.

Noteworthy Observations at an Embankment Dam

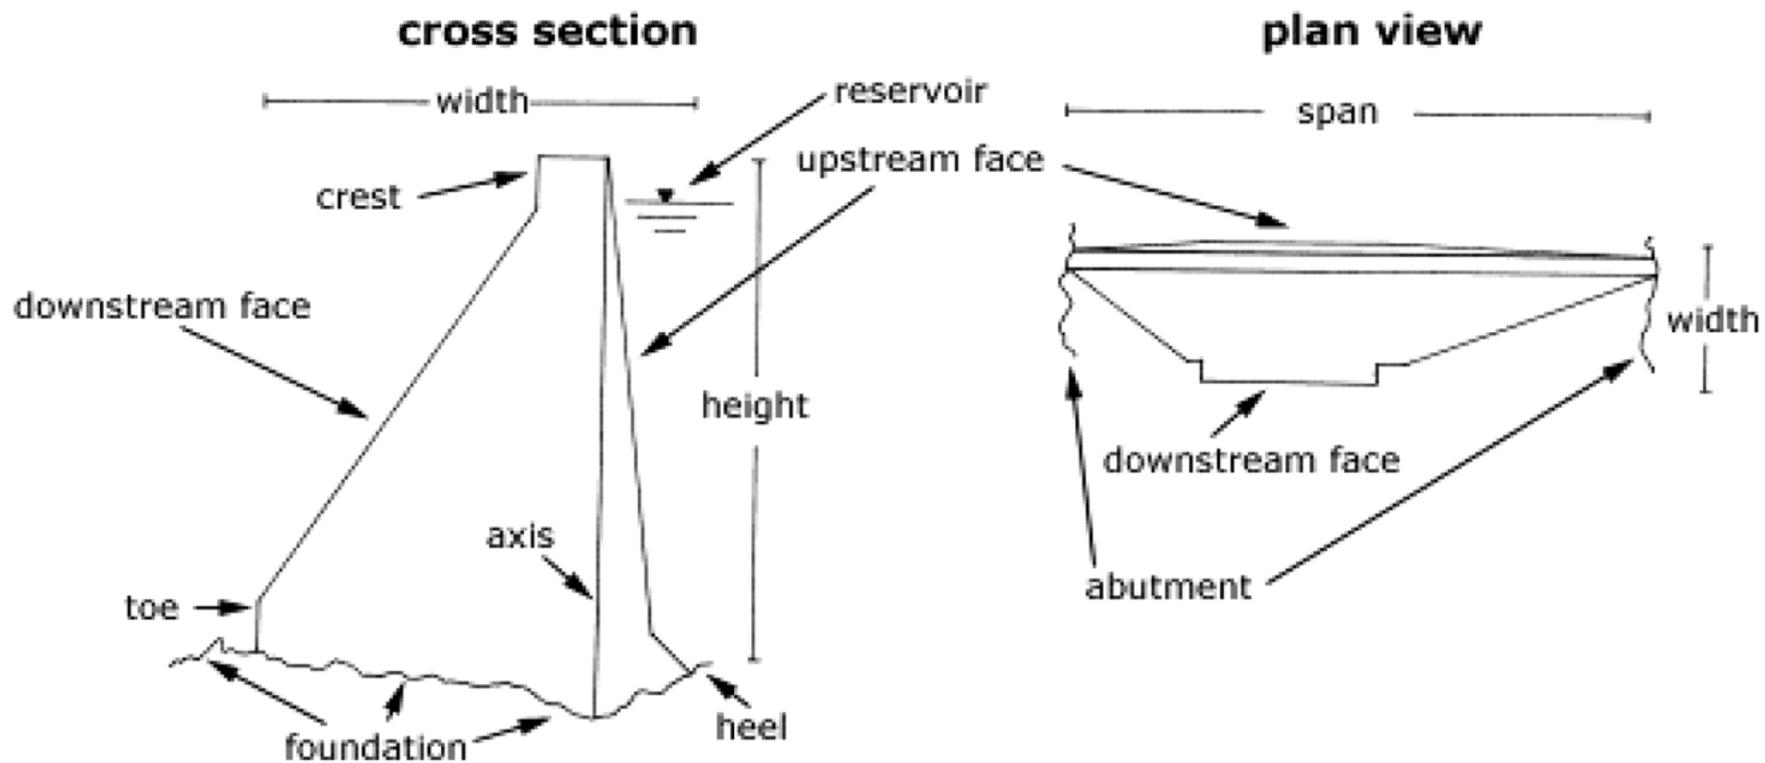
Figure 3 – Typical gravity dam views showing common terms (www.simscience.org).

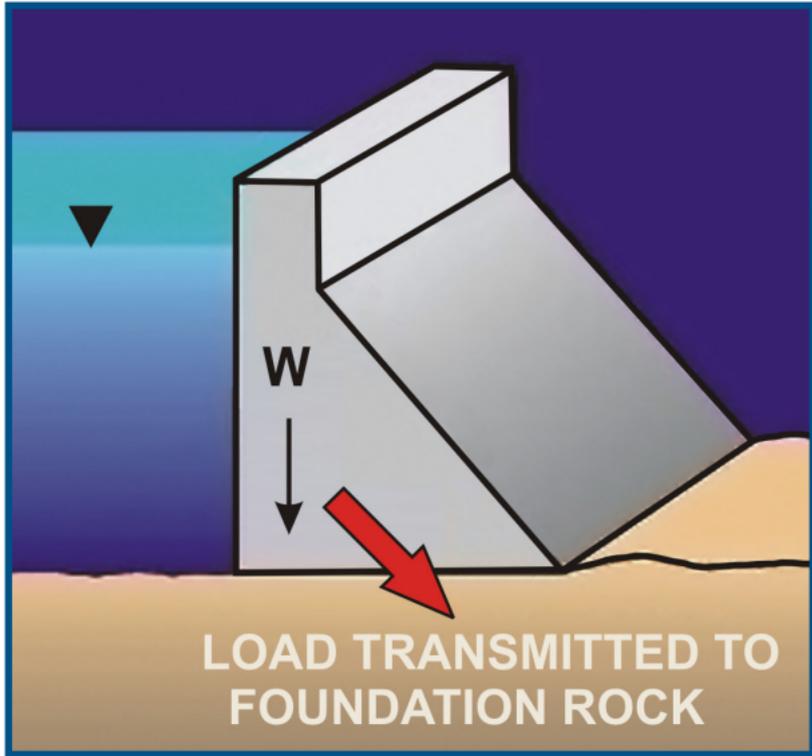
Figure 4 – Gravity dam cross-section showing load transmission to foundation.

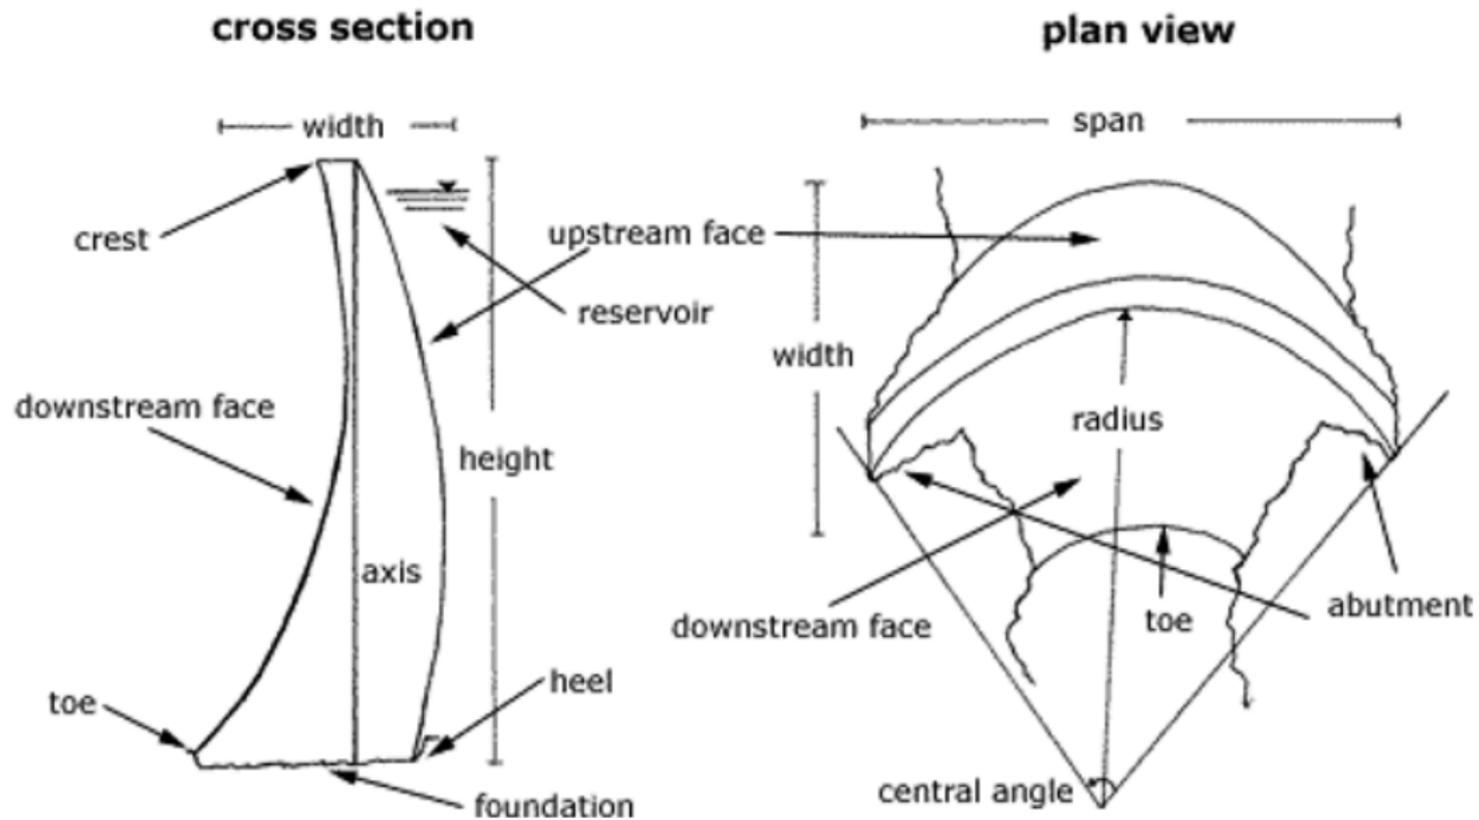
Figure 6 – Typical arch dam views showing common terms (www.simscience.org).

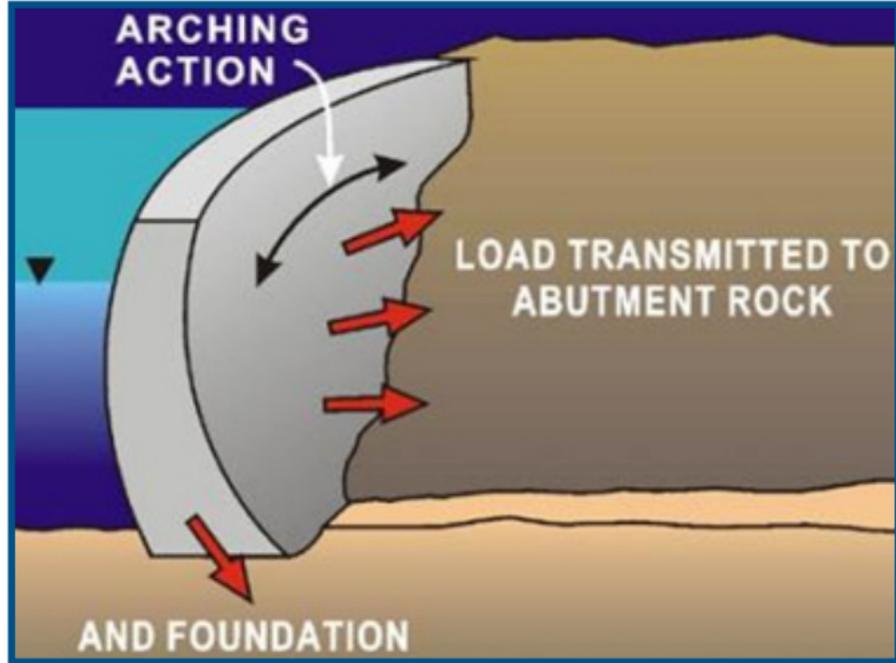
Figure 7 – Arch dam cross-section showing load transmission into foundation and abutment.

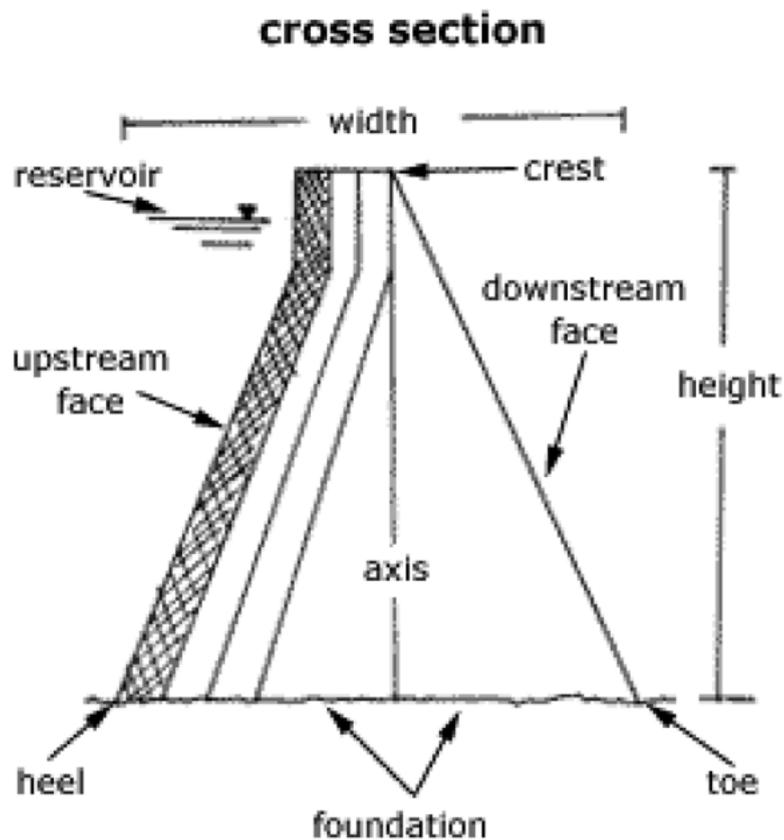
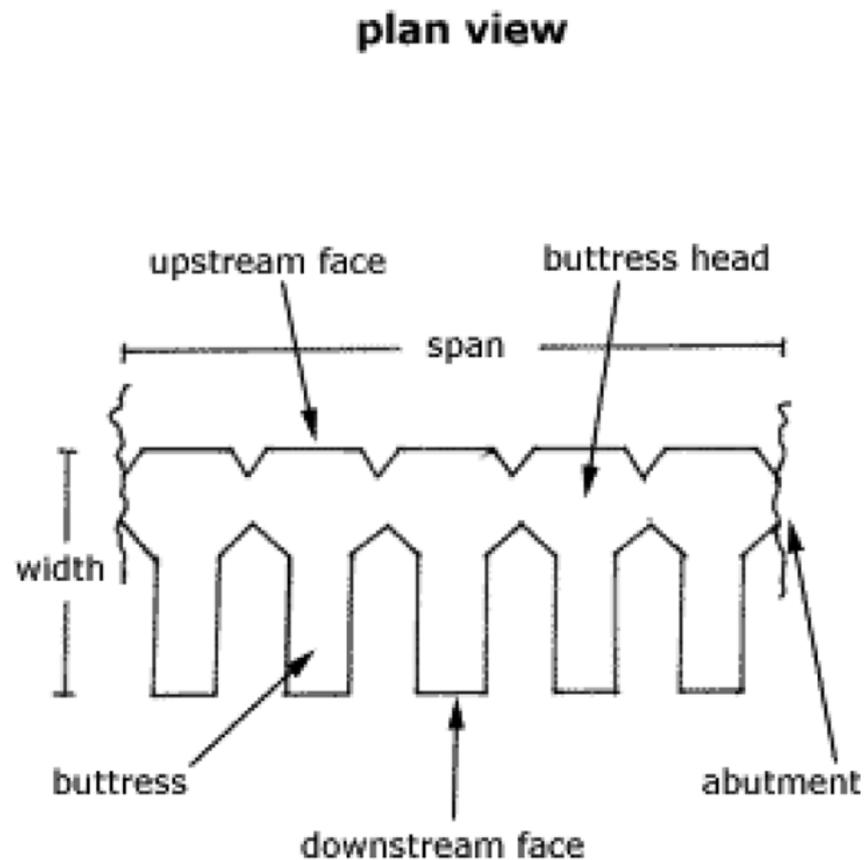
Figure 9 – Typical buttress dam diagram showing common terms (www.simscience.org).

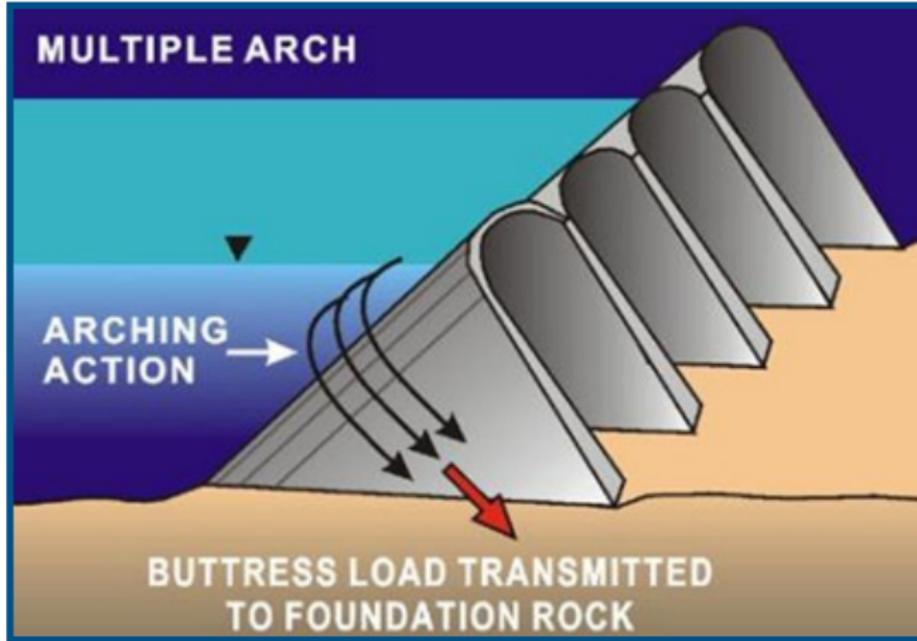
Figure 10 – Arch dam cross-section showing load transmission into foundation and abutment.

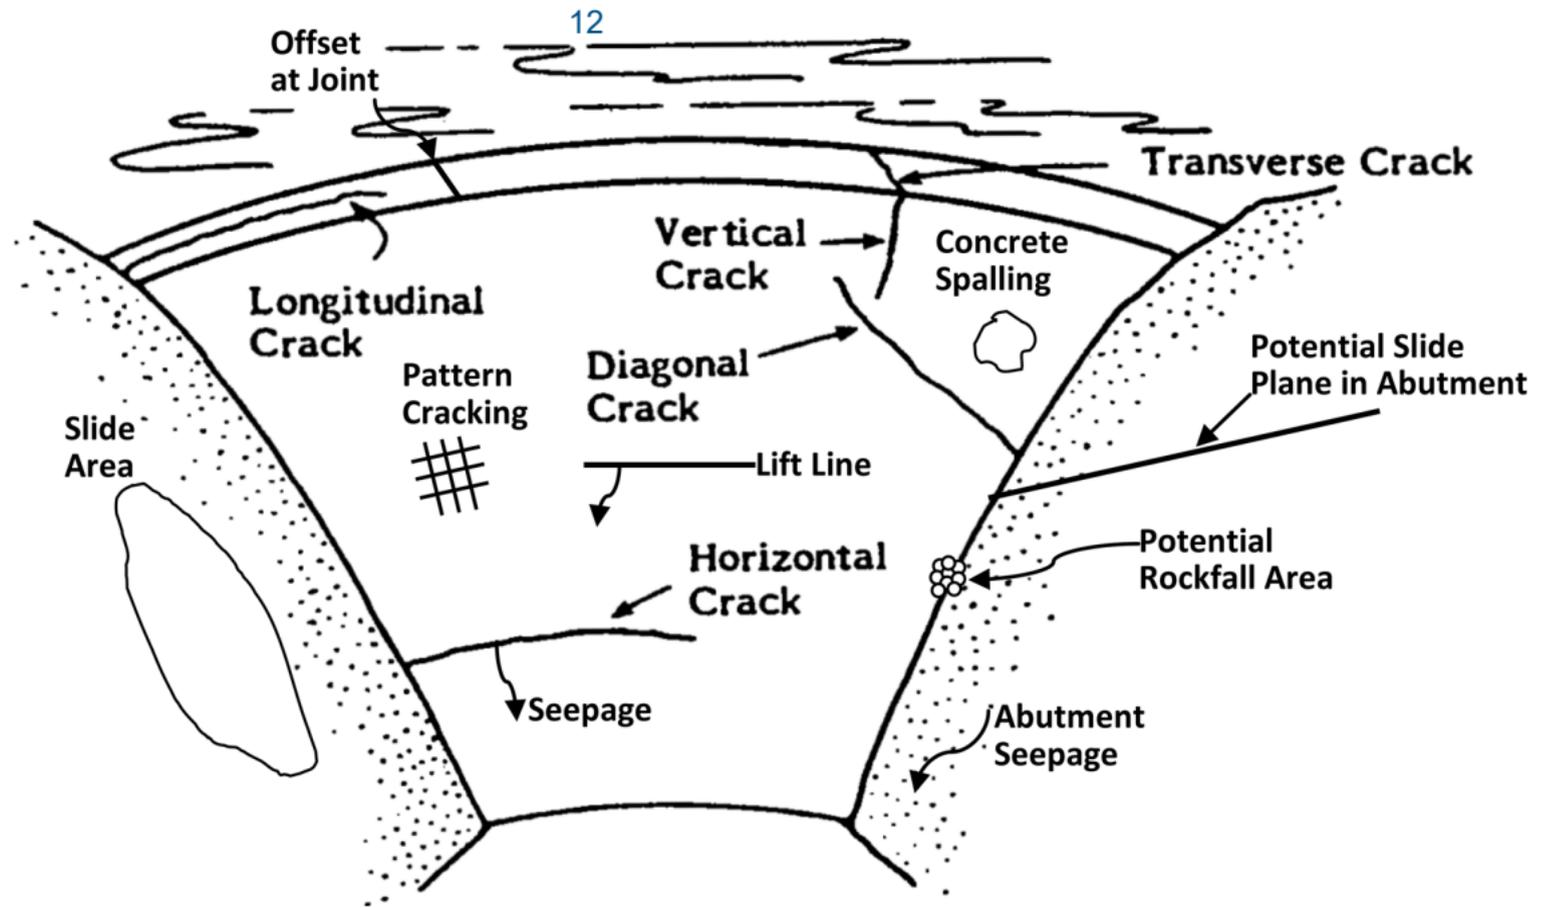
Figure 13.

Noteworthy Observations at a Concrete Dam

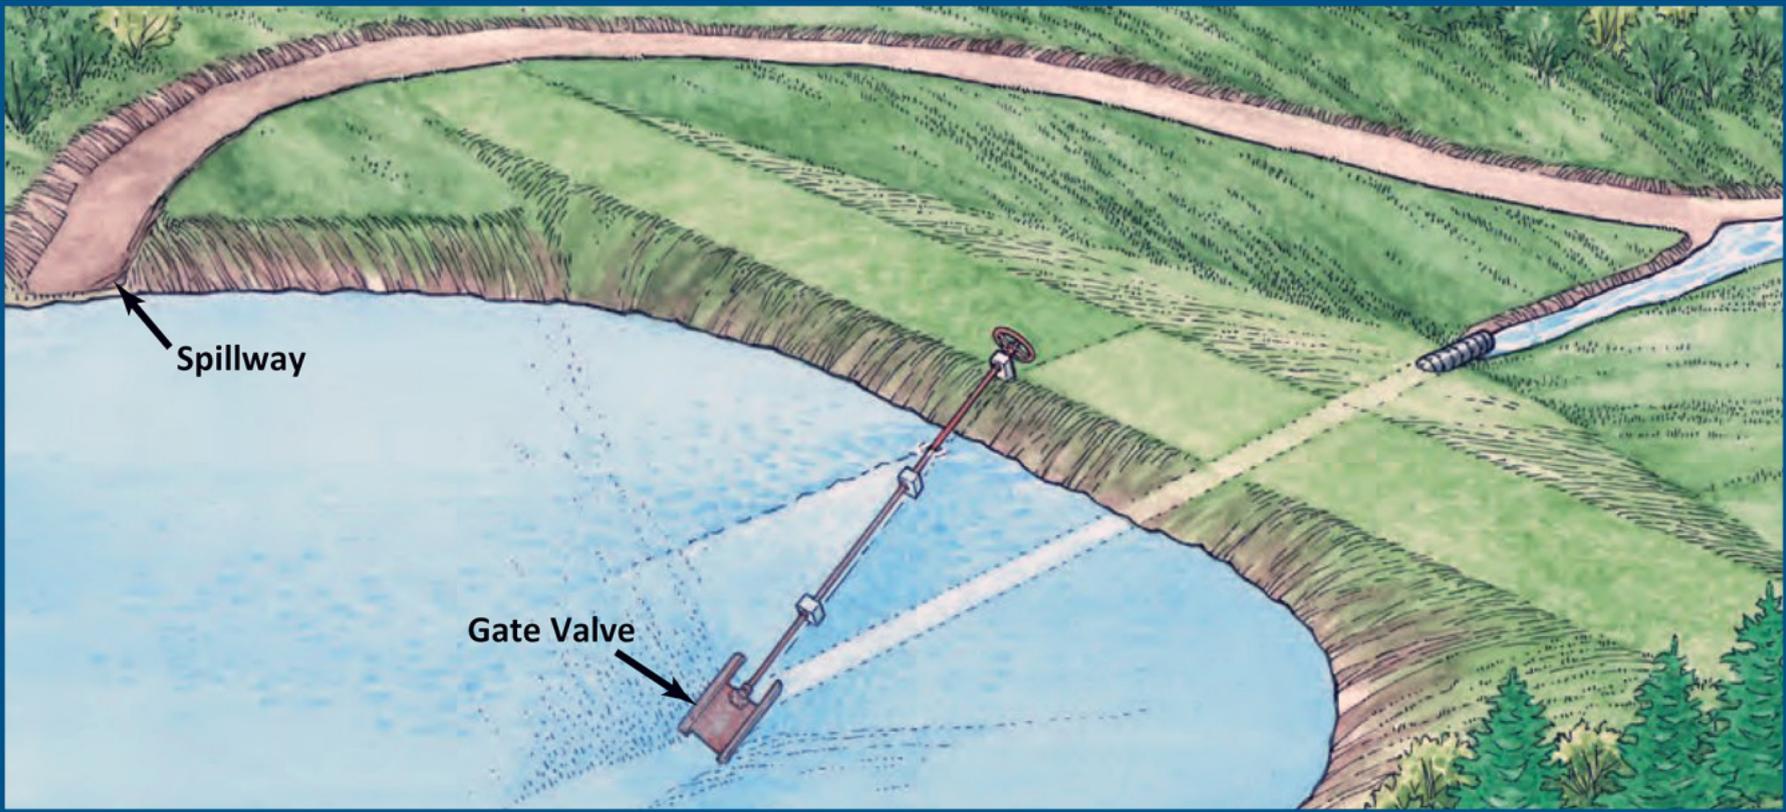
Figure 14 – Typical gate valve used with a spillway to control water level.

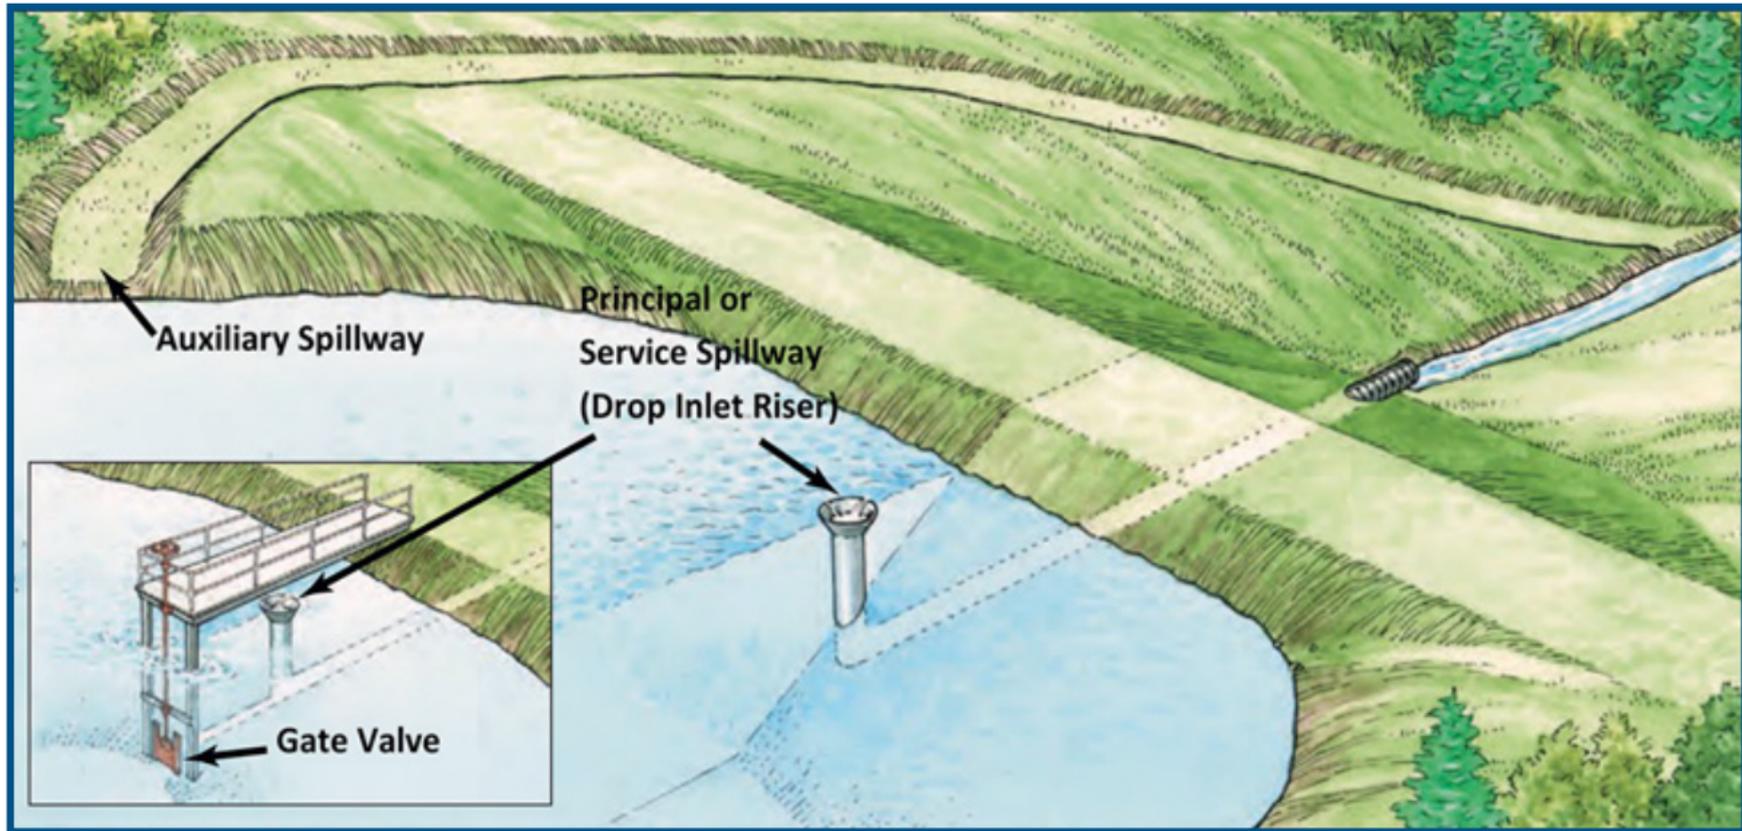
Figure 15 –
Typical drop inlet
riser serving as a
principal or service
spillway to control
water level.

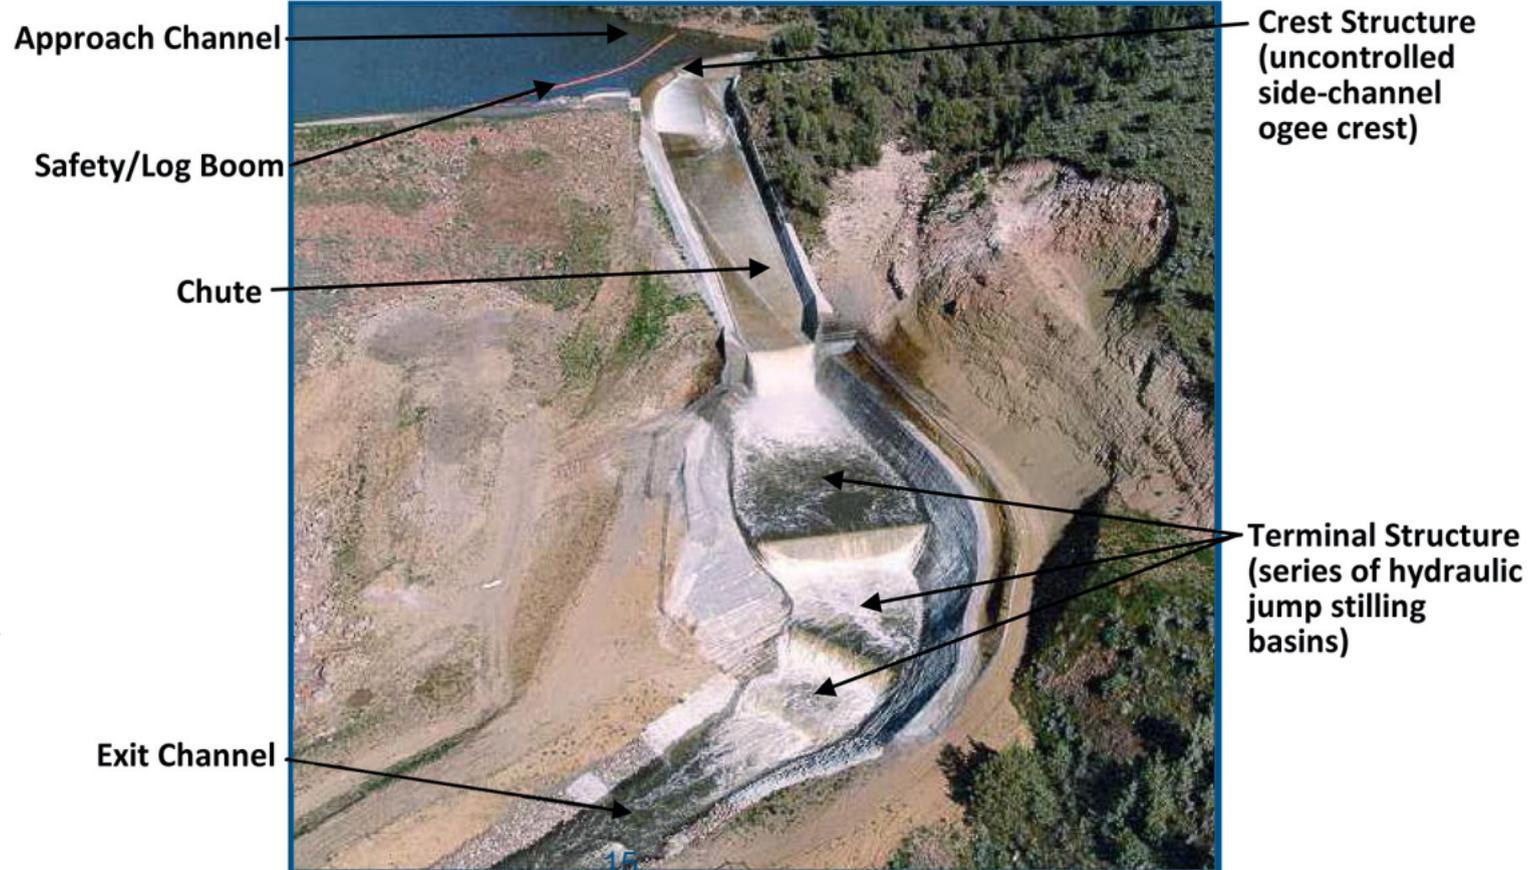
Figure 16 – Spillway Overview with structures identified.

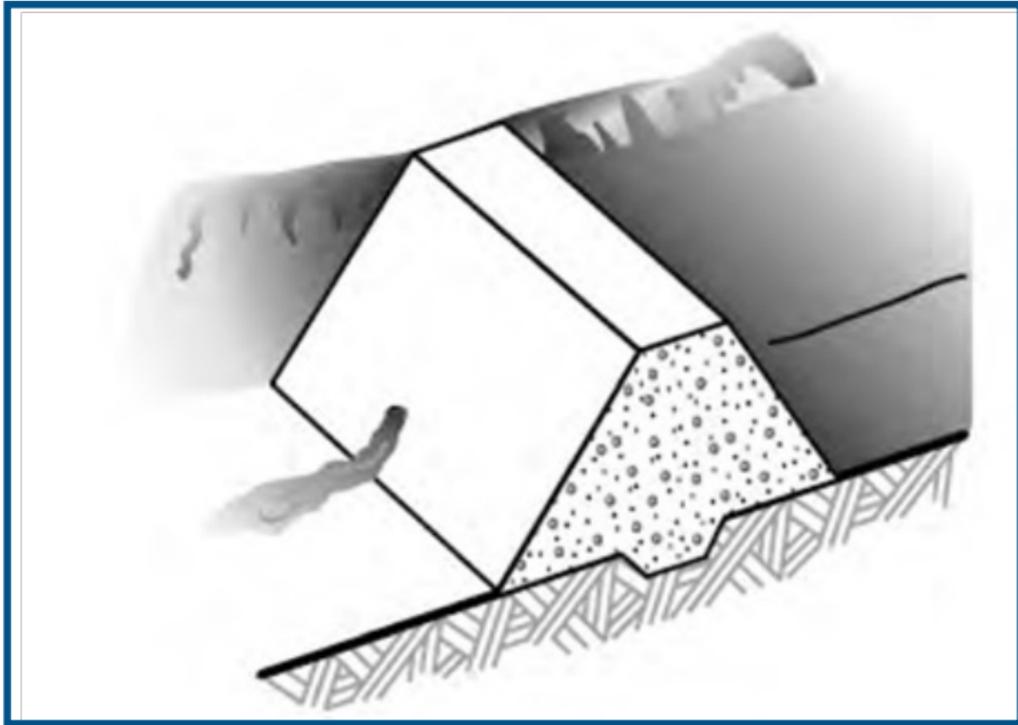
- Water has created an open pathway, channel, or pipe through the dam. The water is eroding and carrying embankment material.
- Rodents, frost action, or poor construction may allow seepage water to create an open pathway or pipe through the embankment.
- Continued flows can further erode embankment and/or foundation materials and lead to dam failure.

Figure 17 – Excessive quantity and/or muddy seepage water exiting from a point.

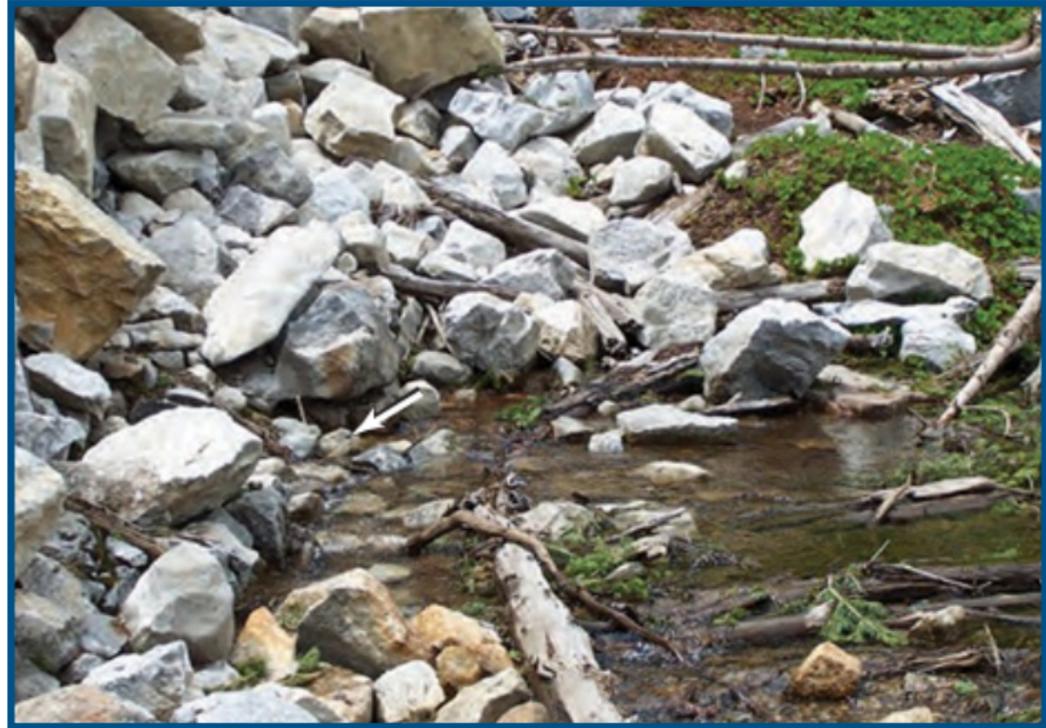
Figure 18 – Excessive seepage water exiting at the toe of the embankment.

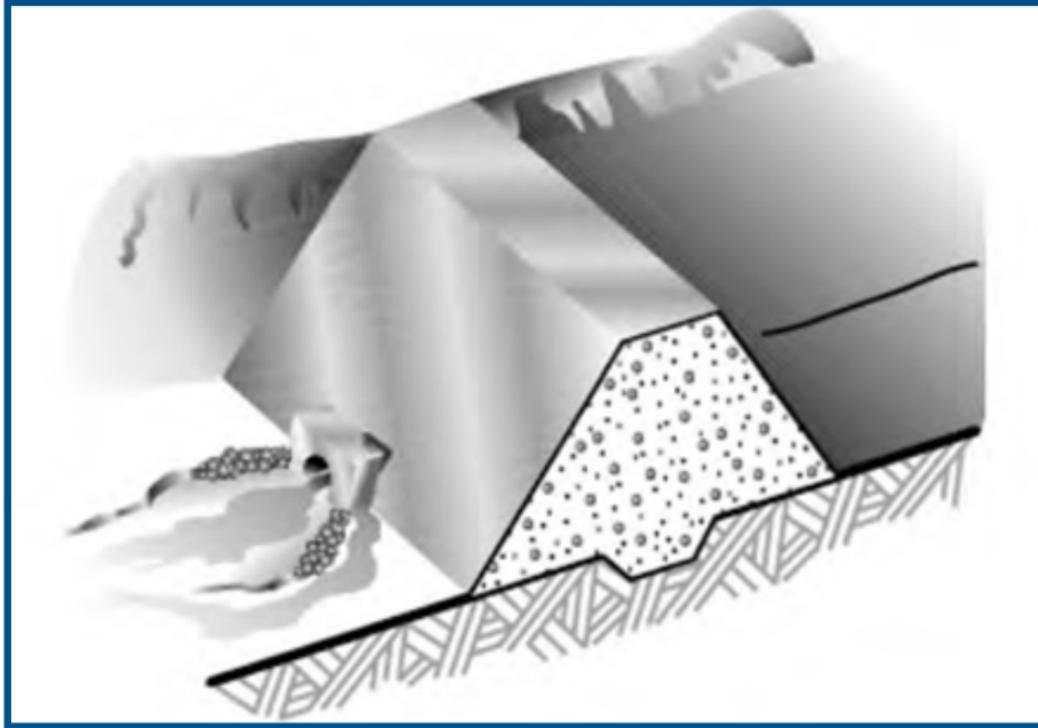
- A break or hole in the outlet pipe or poor compaction around the pipe allows water to flow and creates a pathway along the outside of the outlet pipe.
- Continued flows can lead to embankment and/or foundation material erosion and dam failure.

Figure 19 – Seepage water exiting from a point adjacent to the outlet pipe.

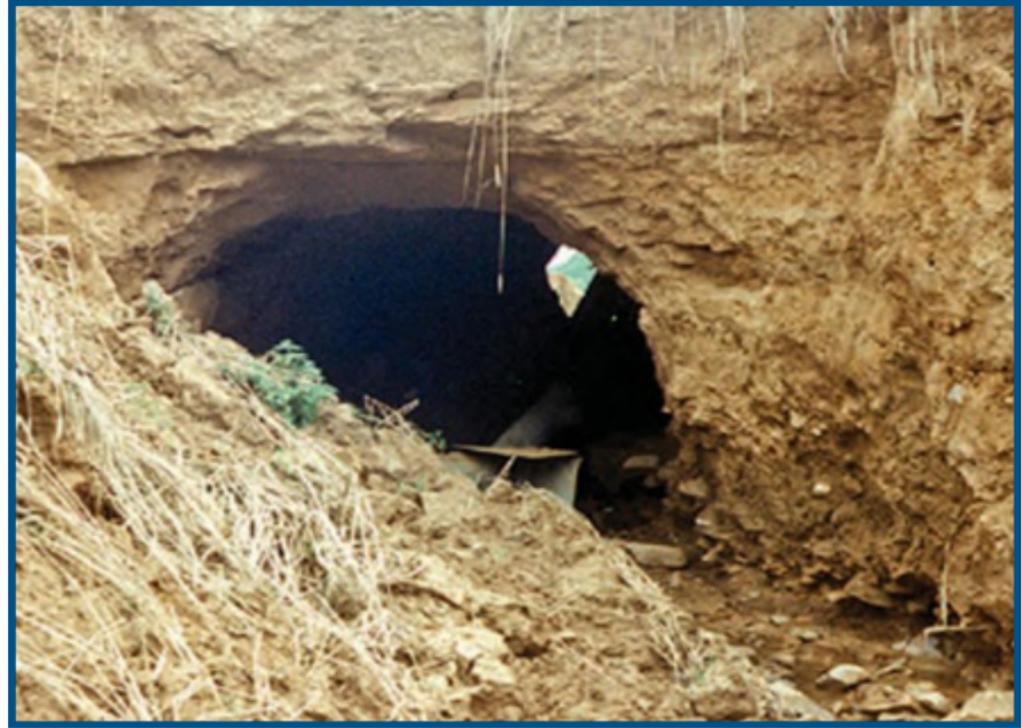
Figure 20 – Embankment erosion adjacent to an outlet pipe.

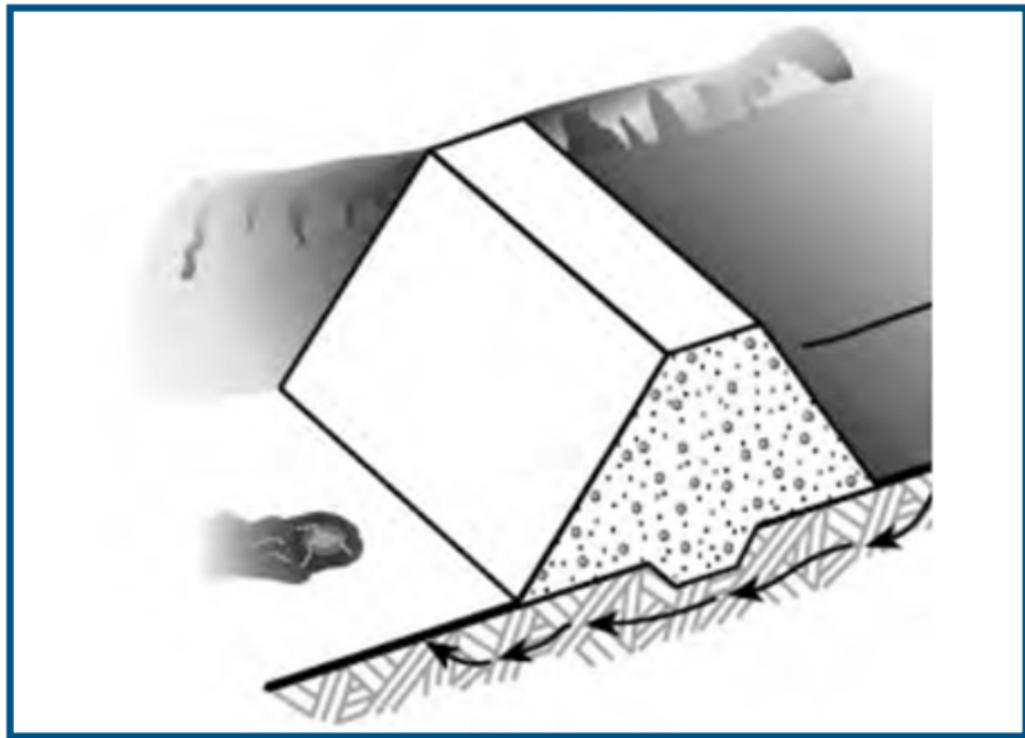
- Some part of the foundation material is supplying a path for reservoir seepage. This could be caused by a sand or gravel layer in the foundation.
- Increased flows can lead to high upward gradients and erosion of the foundation materials and dam failure.

Figure 21 – Seepage water exiting as a boil downstream of the dam.

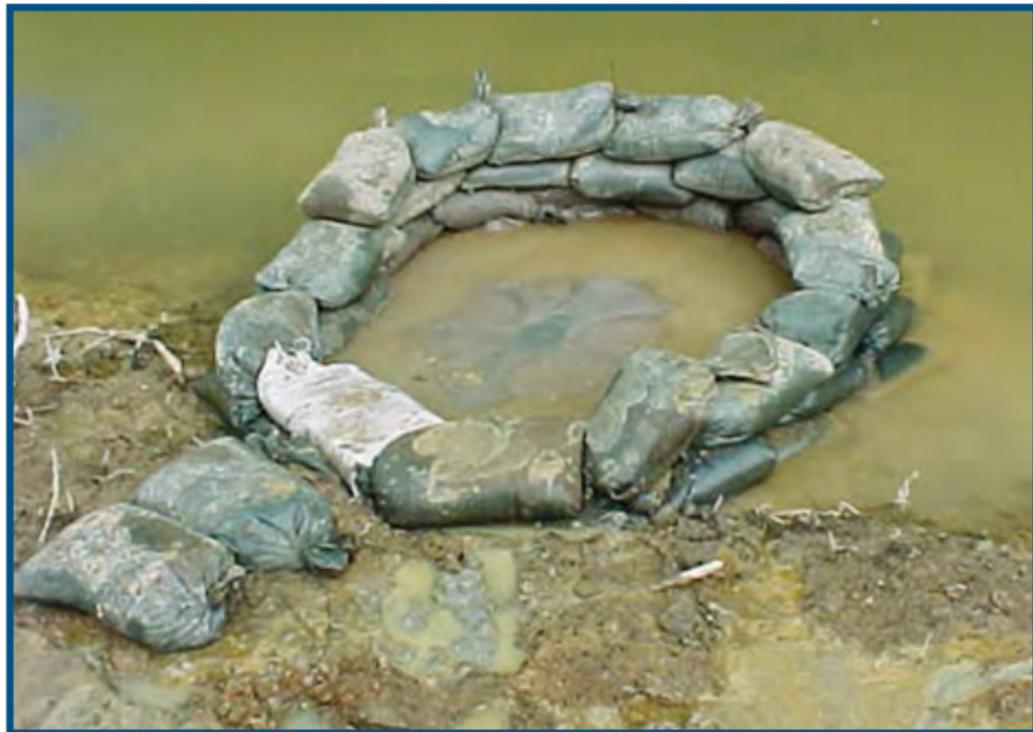
Figure 22 – Sandbags surrounding a boil on the downstream side of the dam (note the mound of material forming in the center of the sand-bagged area).

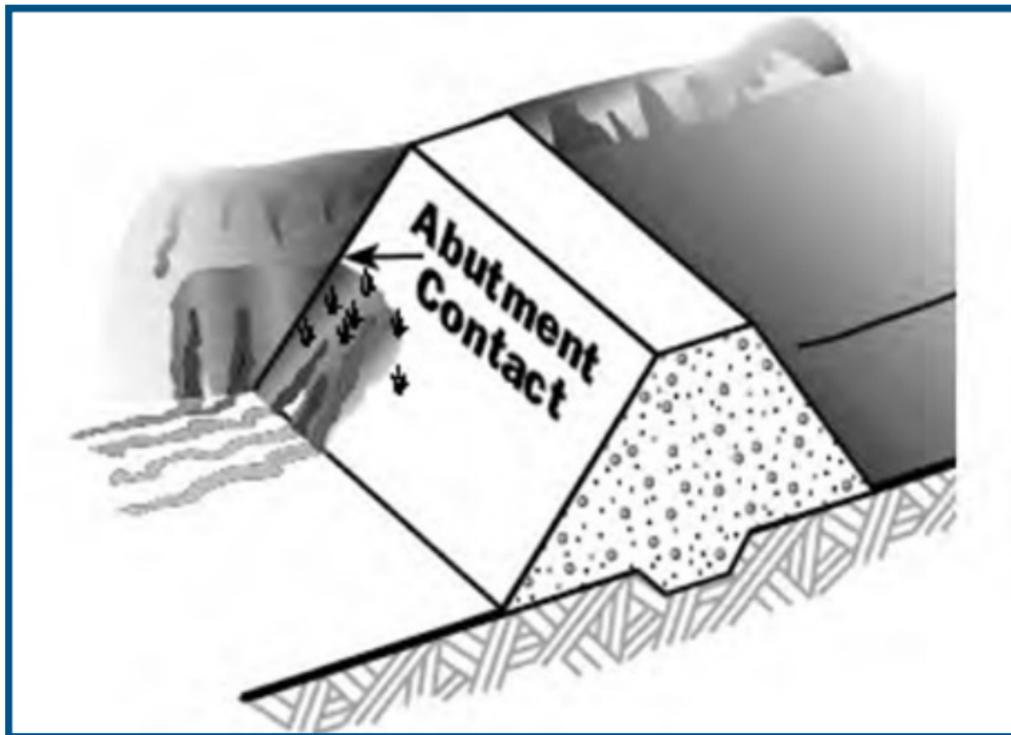
- Water flowing through pathways in the abutment or along embankment abutment contact can result in internal erosion.
- Seepage can lead to erosion of the embankment material and dam failure.

Figure 23 – Seepage exiting at the abutment contact (groin).

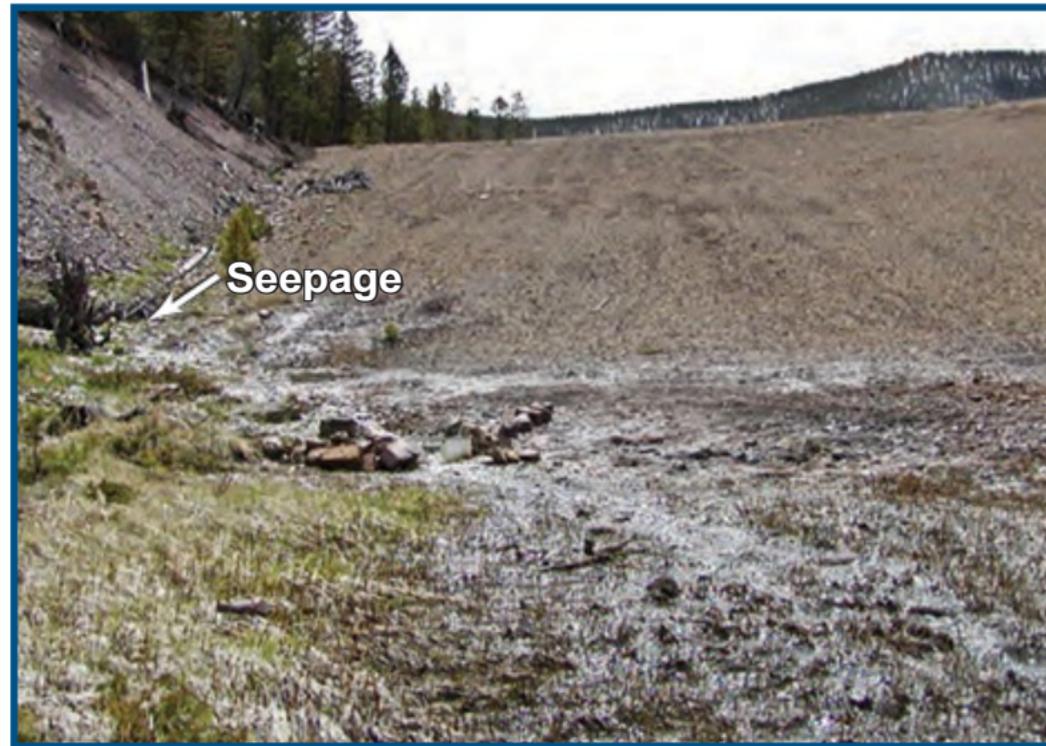
Figure 24 – Seepage at the abutment contact (groin) can lead to dam failure.

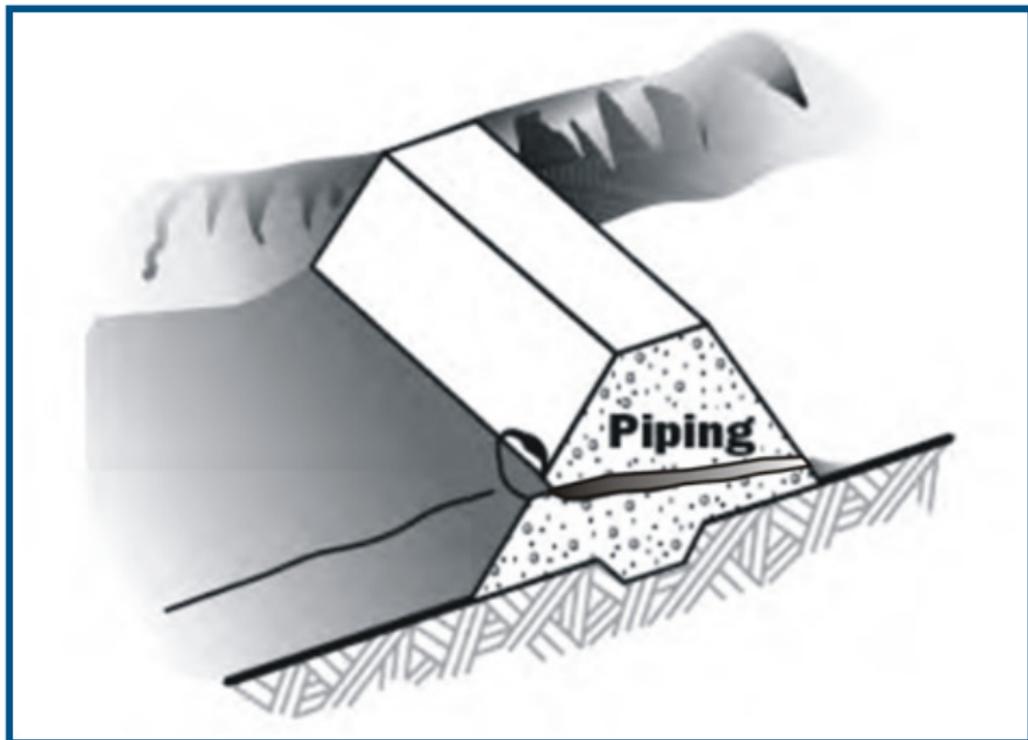
- Internal erosion (piping) of embankment materials or the foundation can cause a sinkhole.
- An eroded cavern (cave-in) can result in a sinkhole.
- A small hole in the wall of an outlet pipe can develop into a sinkhole.
- Seepage with sediment at the seepage exit indicates potential internal erosion of the dam embankment or foundation.
- Internal erosion can lead to dam failure as soil pipes develop and erode through the dam embankment and/or foundation.

Figure 25 – Sinkholes.

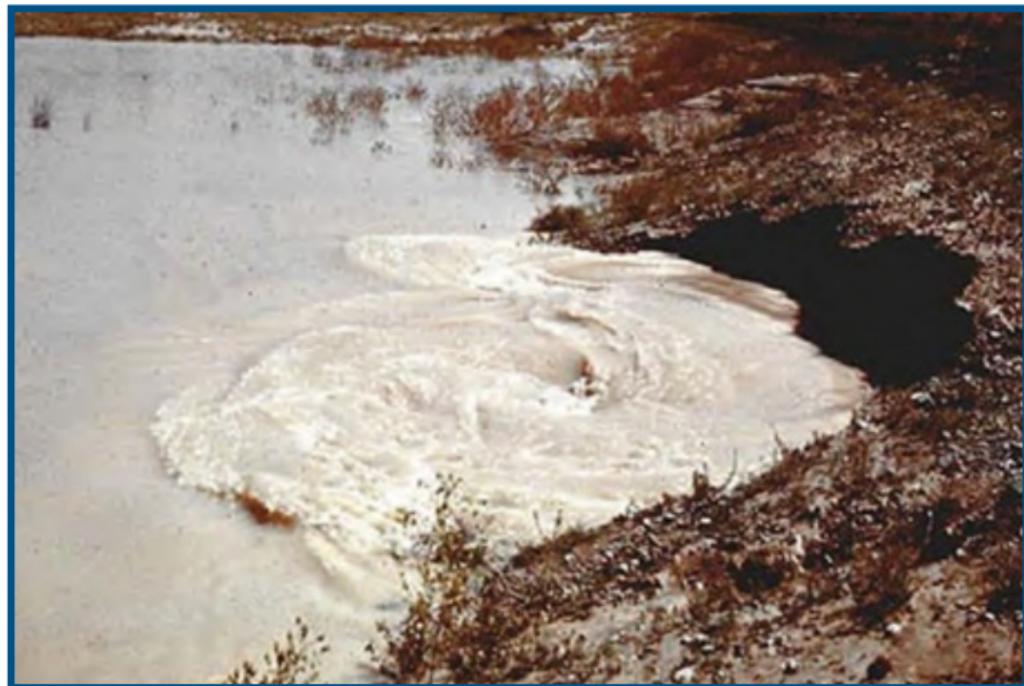
Figure 26 – Whirlpool action in the reservoir (unrelated to an outlet works intake) could be an indication of advanced piping. Dam failure could be imminent.
