Pocket Safety Guide for Dams and Impoundments

FEMA P-911 / October 2016

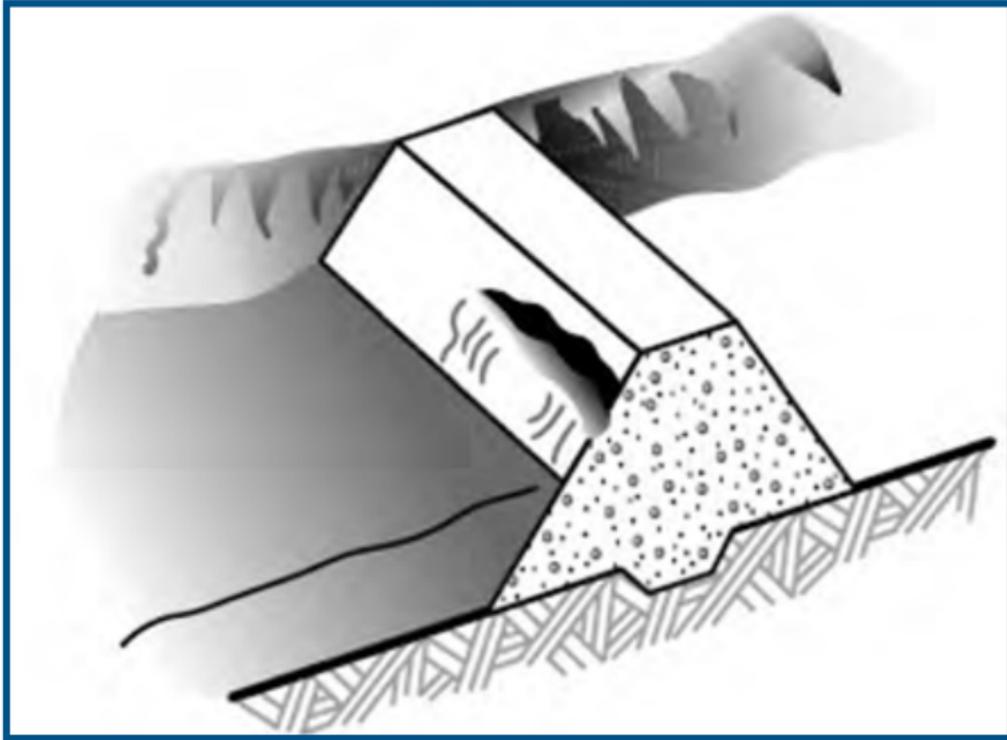
- Foundation movement or a too steep slope can cause earthfill to move along a slip plane which can lead to a slump or slip of the embankment.
- Slide movements in the reservoir basin can lead to inlet obstruction or dam failure (through instability in the faces of the dam, or through wave action if the slide is along the perimeter of the reservoir).

Figure 27 – Slide, slump or slip on either face.

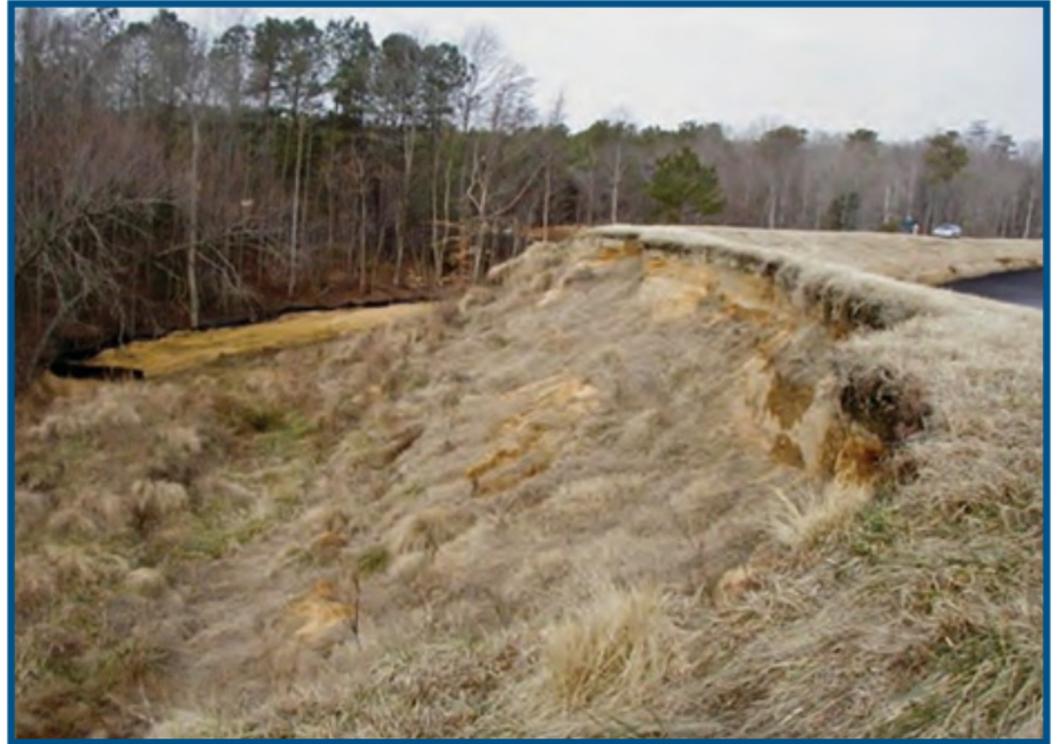
Figure 28 – Slumping on the downstream face of a dam.

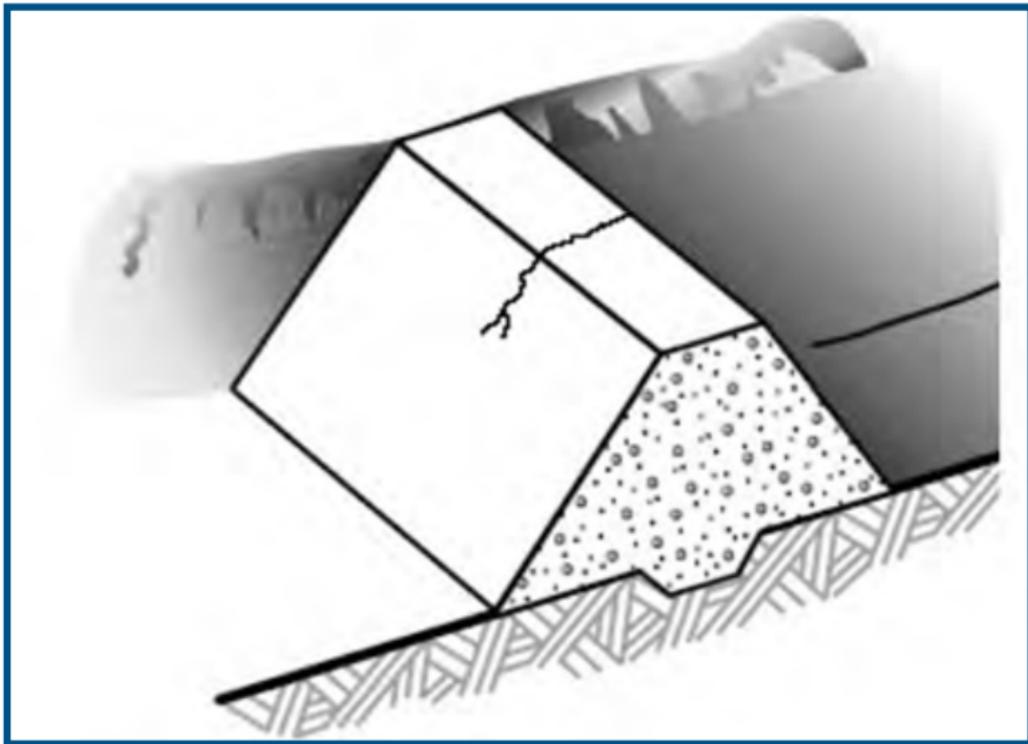
- Differential settlement between adjacent segments of the embankment may cause transverse cracking.
- Deformation caused by differential settlement or slope instability may provide a path for seepage through the embankment cross section, which could initiate a breach of the embankment.

Figure 29 – Transverse cracking.

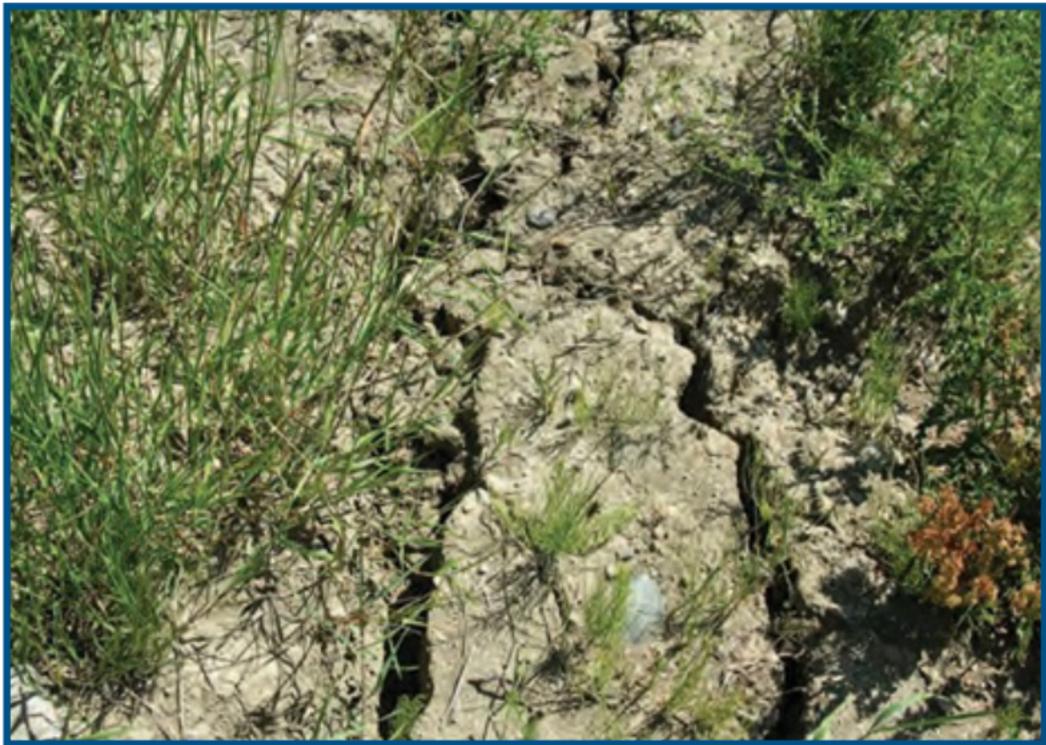
Figure 30 – Transverse cracks may provide open seepage paths through an embankment dam.

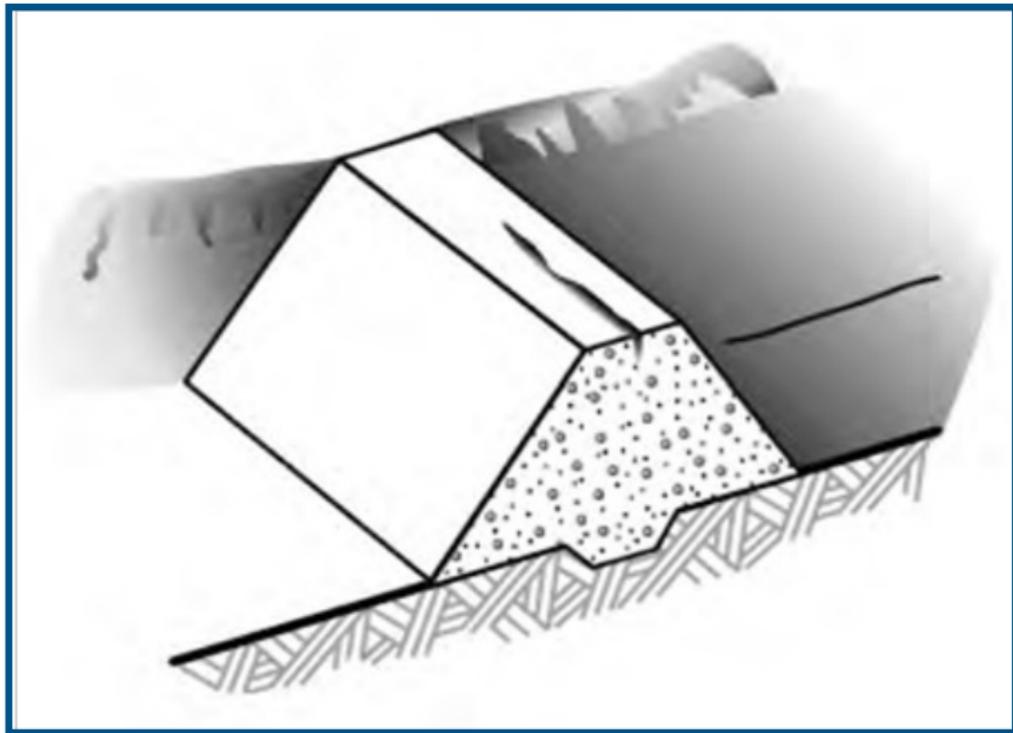
- Slope instability can result in longitudinal cracks.
- After an earthquake, longitudinal cracks could indicate liquefaction of the foundation and/or embankment materials may have occurred, which resulted in slope movements.
- Differential settlement between zones or within the embankment may cause longitudinal cracking.
- Cracks create a point for water to enter the embankment, which could result in slope instability.

Figure 31 – Longitudinal crack.

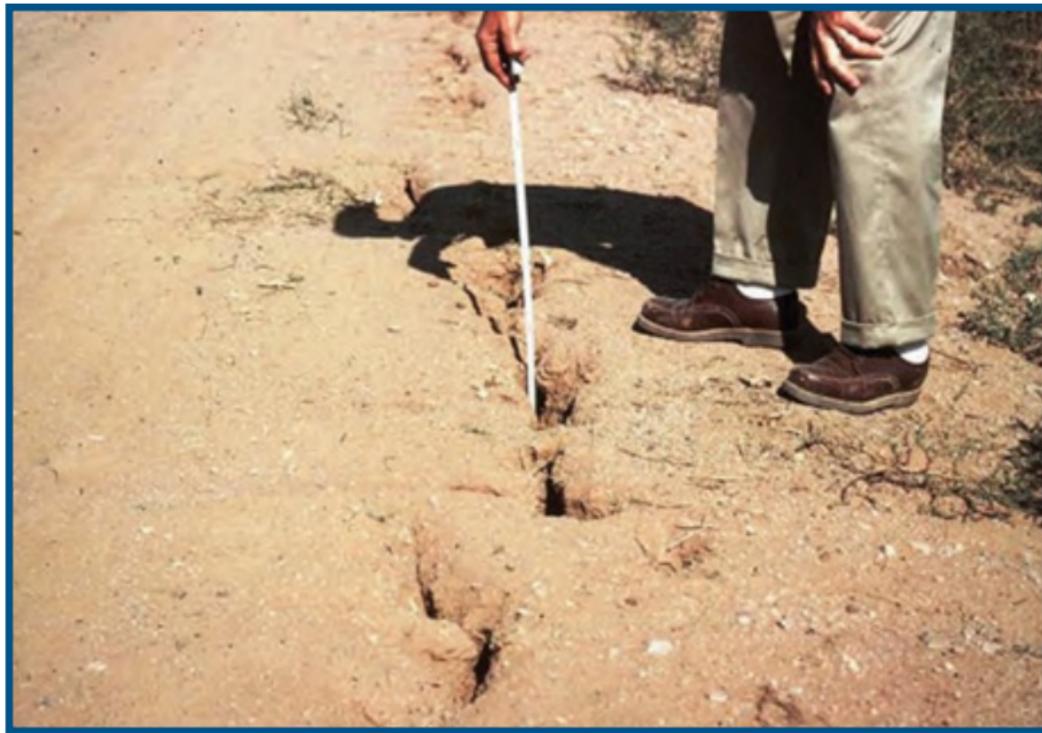
Figure 32 – Longitudinal cracks can be an indication of dam instability.

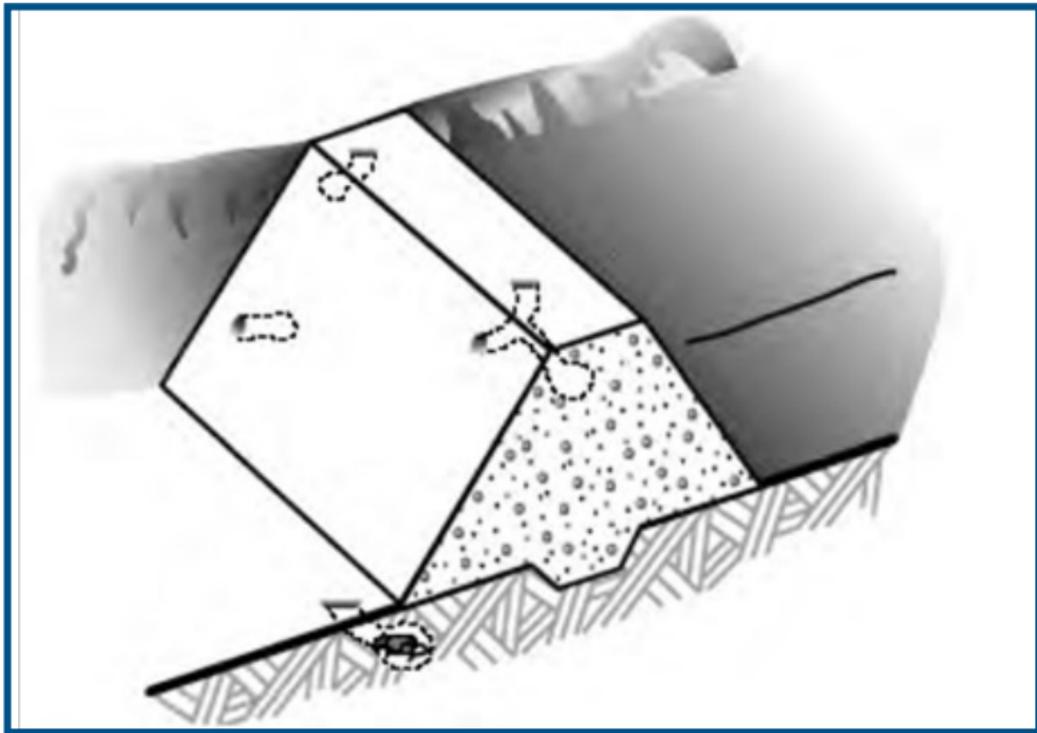
- Cattail-filled areas and areas where trees are close to the reservoir provide ideal habitat and foraging areas for animals.
- An overabundance of rodents increases the chance of animal burrowing, which creates holes, tunnels, and caverns within an embankment dam.
- Tunnels may significantly reduce the length of the seepage path through the dam embankment which could cause initiation of an internal erosion problem.

Figure 33 – Rodent activity.

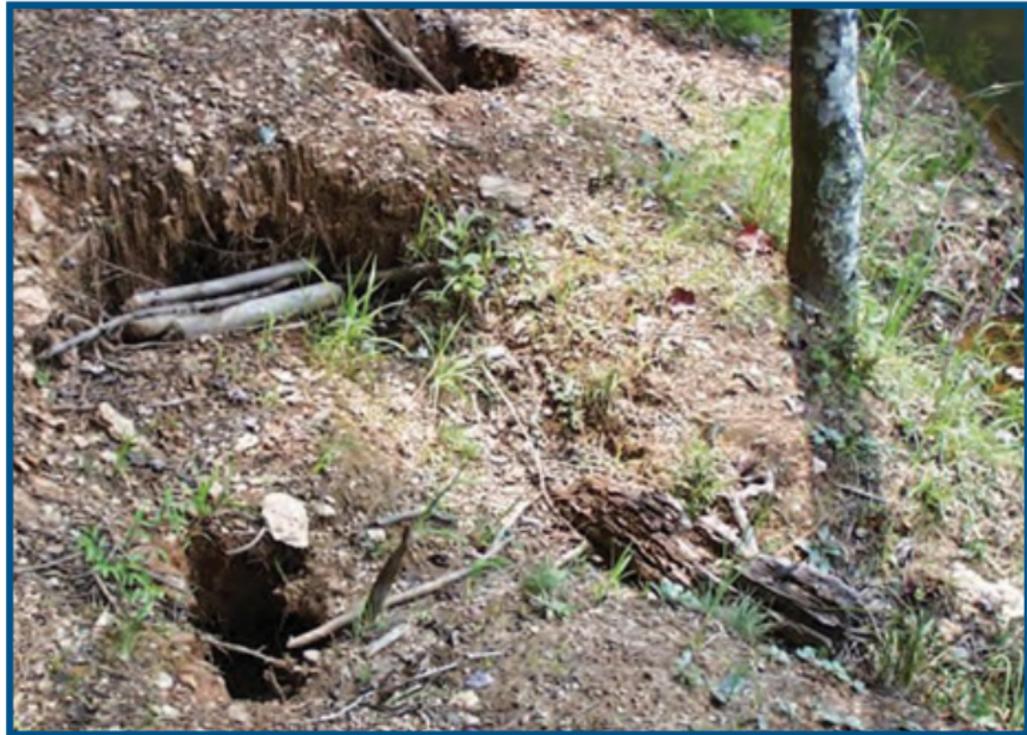
Figure 34 – Rodent holes in the dam face can cause seepage issues that could lead to dam failure.

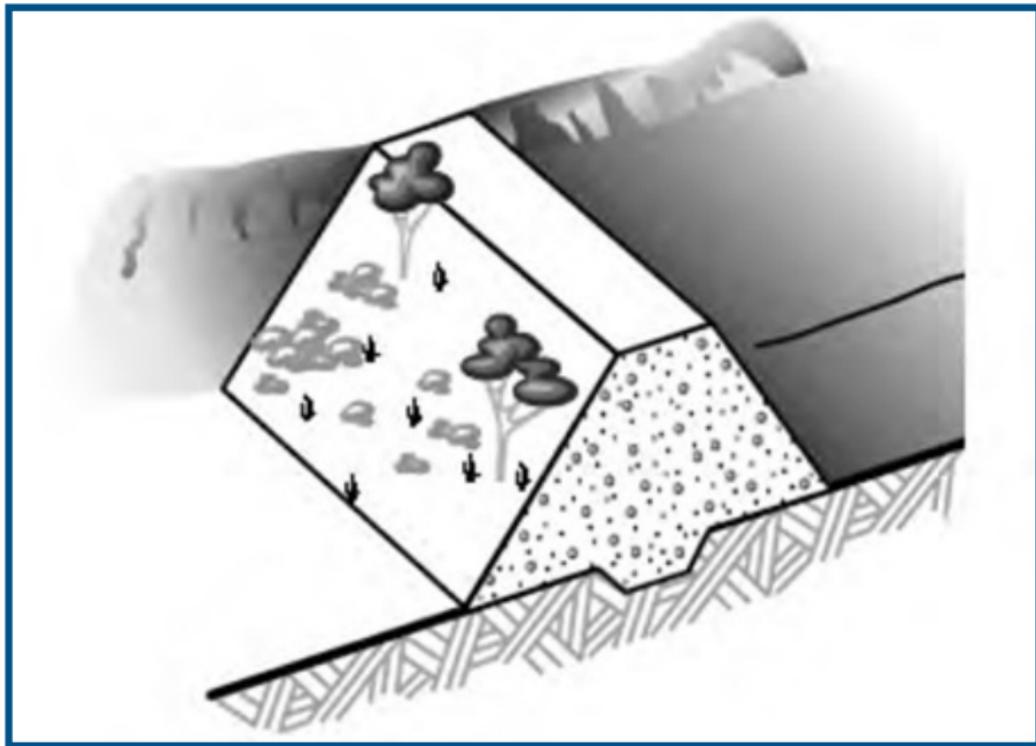
- Natural vegetation (bushes) obscures visual inspection and harbors animals.
- Large tree roots can create seepage paths.
- Large trees can blow over during a storm and damage the dam, which may cause a breach.

Figure 35 – Trees or obscuring vegetation.

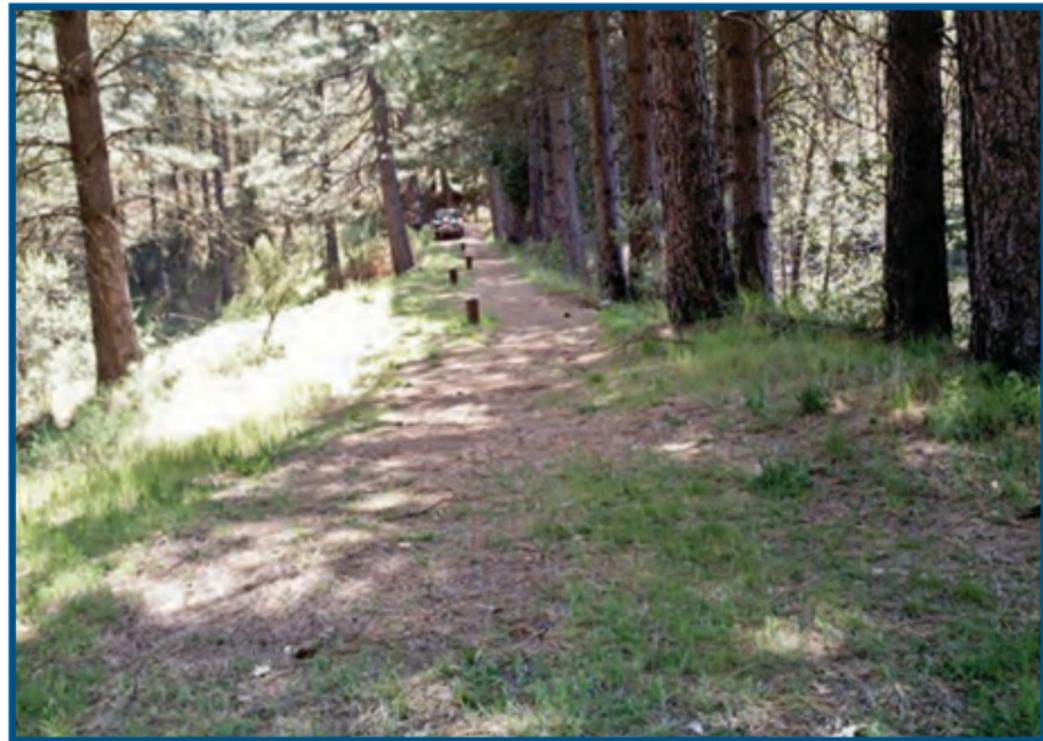
Figure 36 – Trees growing on the crest and the faces of a dam.

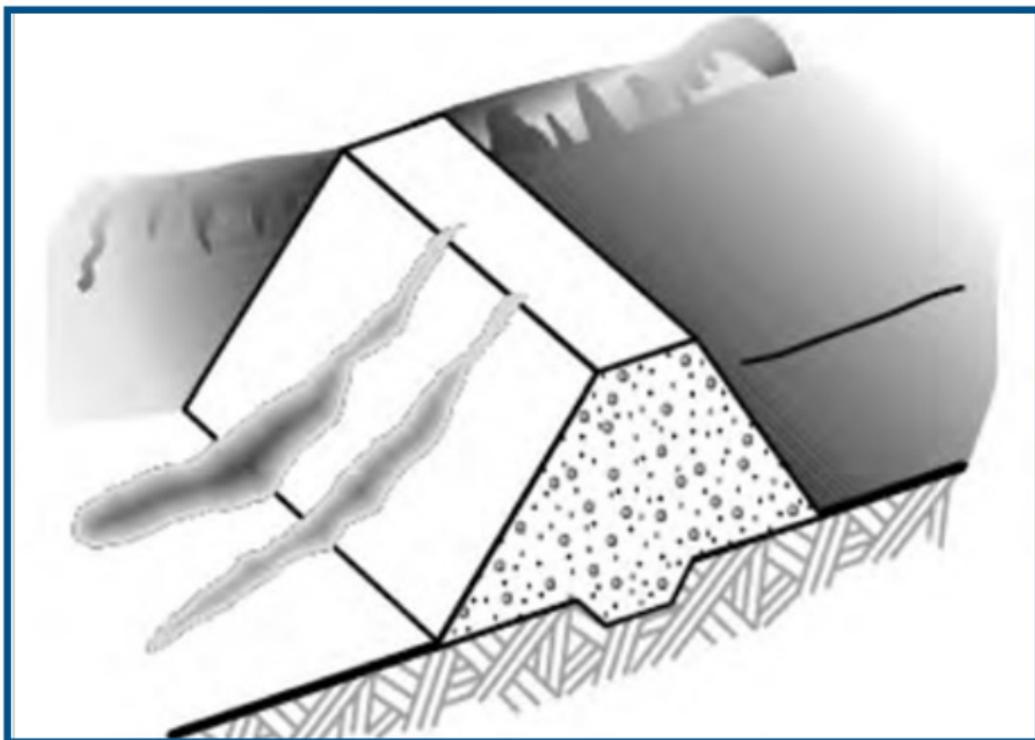
- Water from intense rainstorms or snowmelt carries surface materials down the slope and results in continuous troughs, rills, gullies, etc.
- Erosion can lead to severe deterioration of the downstream slope that can be expensive to repair. It is preferable to catch the problem early, when resolving the issue is much less costly.
- Surface erosion can also occur upstream if the face is not protected with riprap.

Figure 37 – Erosion.

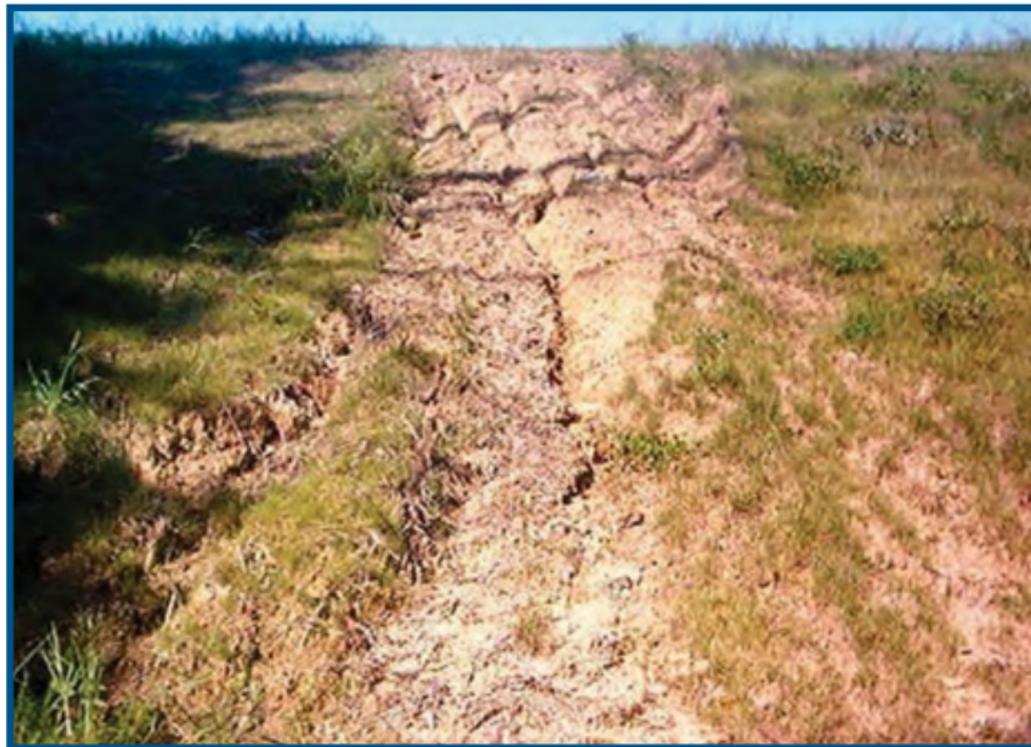
Figure 38 – Erosion on the downstream face of a dam.

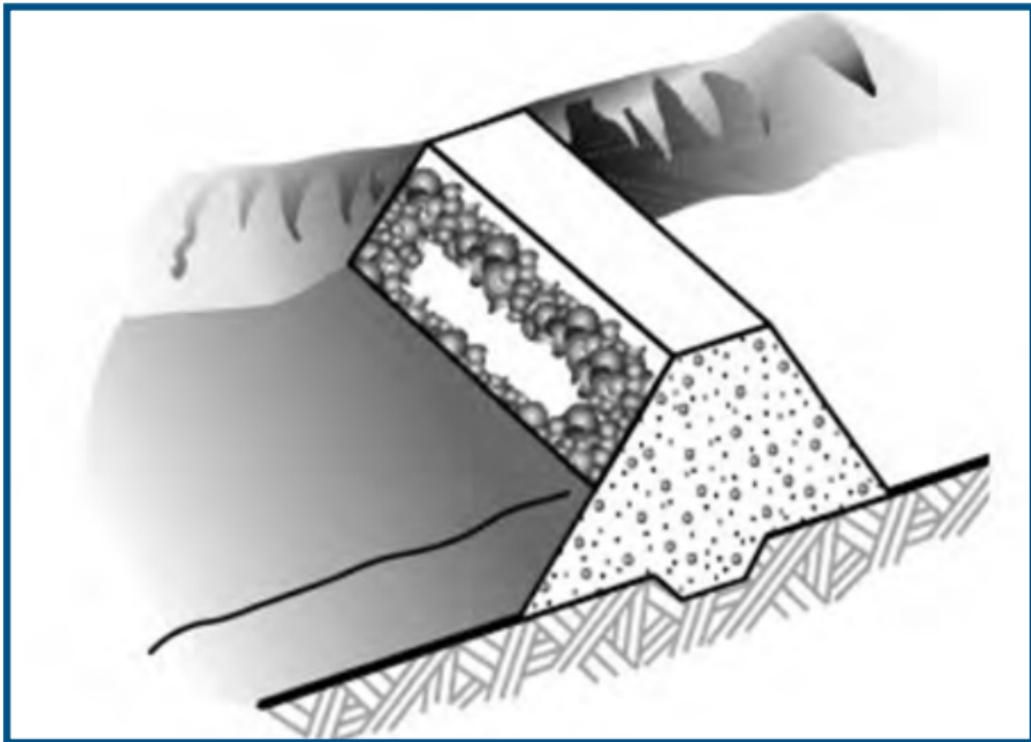
Figure 39 – Broken down or missing riprap.

- Poor quality riprap deteriorates and does not protect the slope.
- Wave or ice action can displace riprap allowing erosion or over-steepening of the bank.
- Improperly sized riprap may displace and expose the slope.
- Wave action against these unprotected areas decreases the embankment width.

- Reestablish the normal slope.
- Place bedding material and properly sized riprap to protect against wave action.

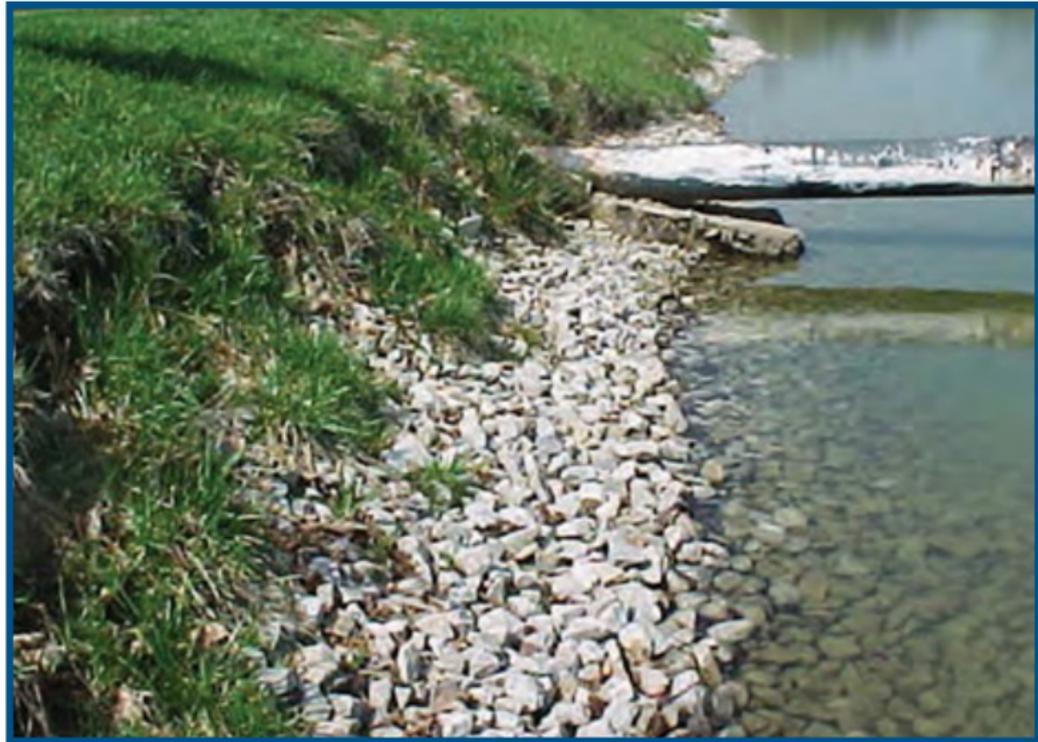
Figure 40 – Wave erosion on the unprotected face of a dam.

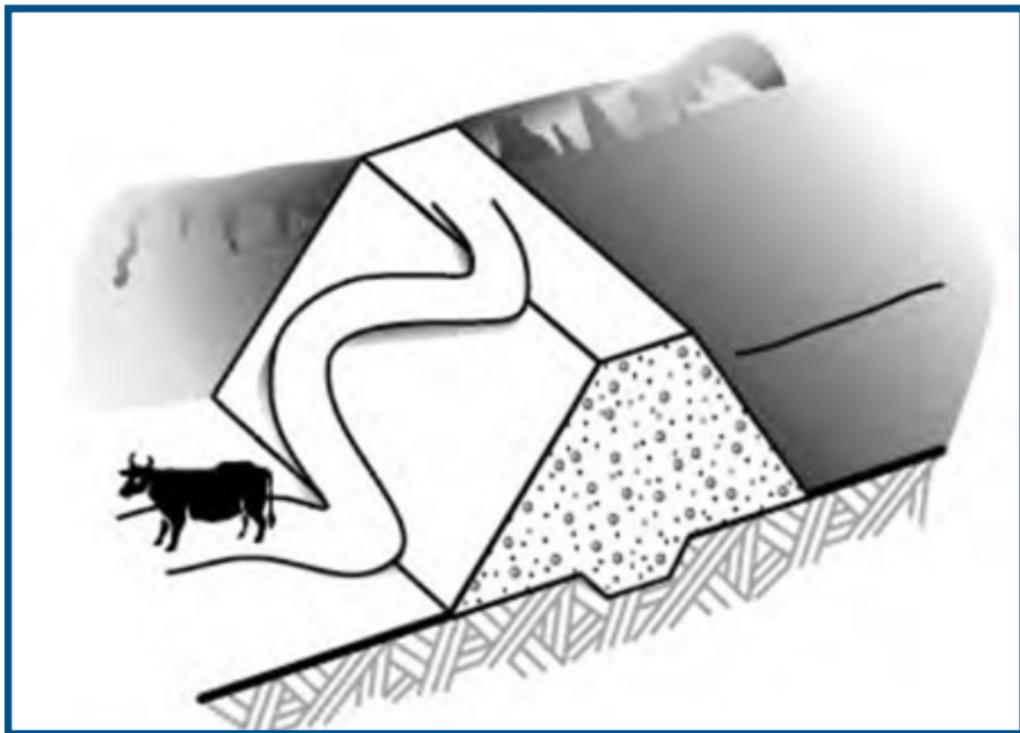
Figure 41 – Livestock and cattle traffic.

- Livestock paths and activities on the downstream dam face can damage slopes, especially when wet.
- Livestock activities may reduce erosion protection leading to erosion issues.

- Fence the embankment area to keep out livestock.
- Repair erosion protection by reestablishing grasses or by placing bedding material and riprap, as applicable.

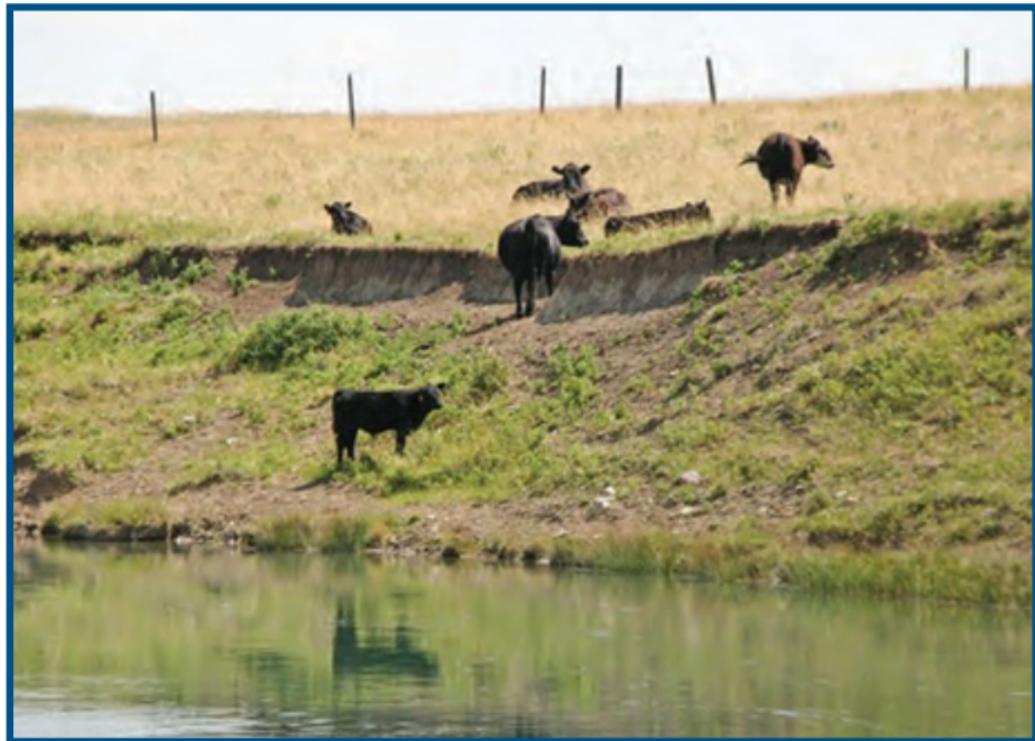
Figure 42 – Livestock paths on dam faces can lead to dam erosion.

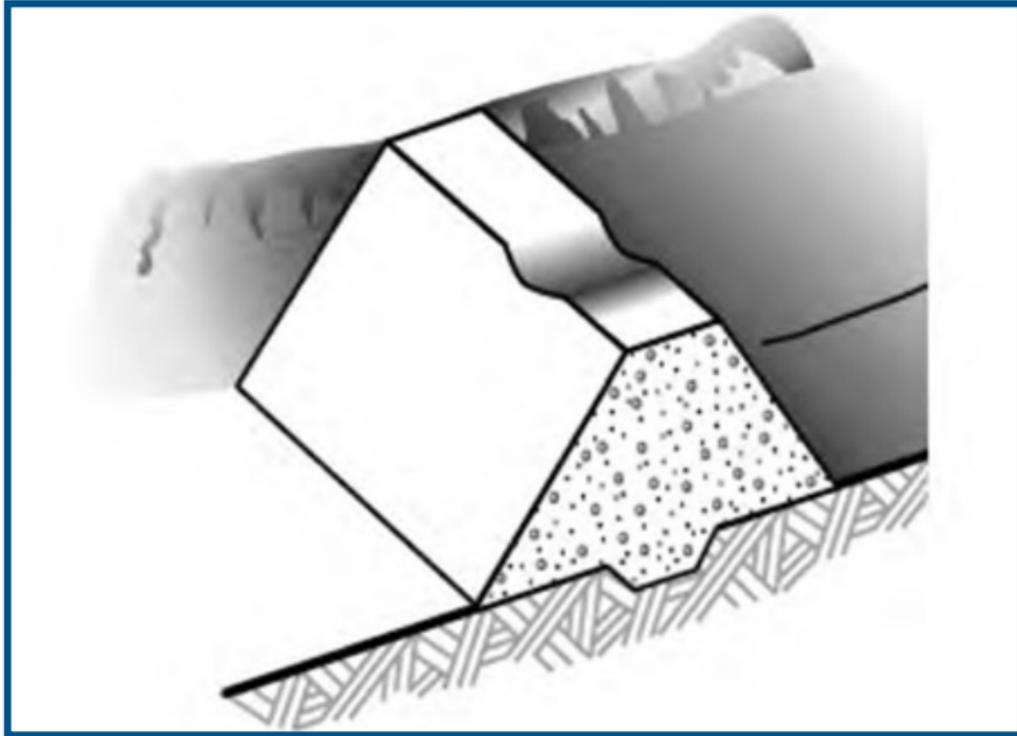
Figure 43 – Low area in the crest of a dam.

- Excessive settlement of the embankment or internal erosion of embankment material may cause a depression on the crest of a dam.
- Foundation spreading upstream and/or downstream, prolonged wind erosion, or improper final grading following construction may cause a low area in the crest of a dam.
- Low area may have been intentionally included during original construction.
- Low areas can reduce the freeboard available and result in the embankment dam overtopping sooner.

- Establish survey monuments or survey along the length of the crest from abutment to abutment to determine the exact amount, location, and extent of low spots on the crest.
- Have a qualified engineer determine the cause of the low area and supervise all necessary steps to reduce any threat to the dam and correct the condition.
- Use proper construction techniques to fill in the low area and reestablish the uniform elevation over the length of the crest.
- Routinely survey established monuments to routinely survey along the dam crest to detect any unusual settlement along the crest of the dam.
- Note: Low areas may be desirable to direct flow over areas of dam less susceptible to damage or having lower consequences from downstream failure.

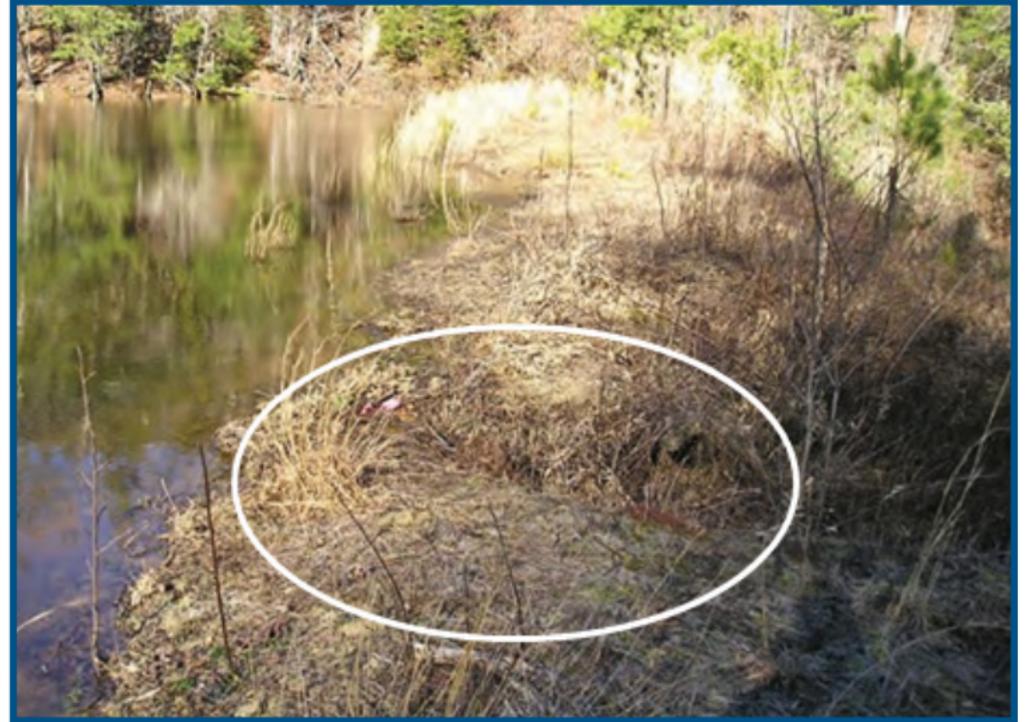
Figure 44 – Low areas in the crest of a dam reduce the freeboard (therefore allowing overtopping at a lower frequency flood).

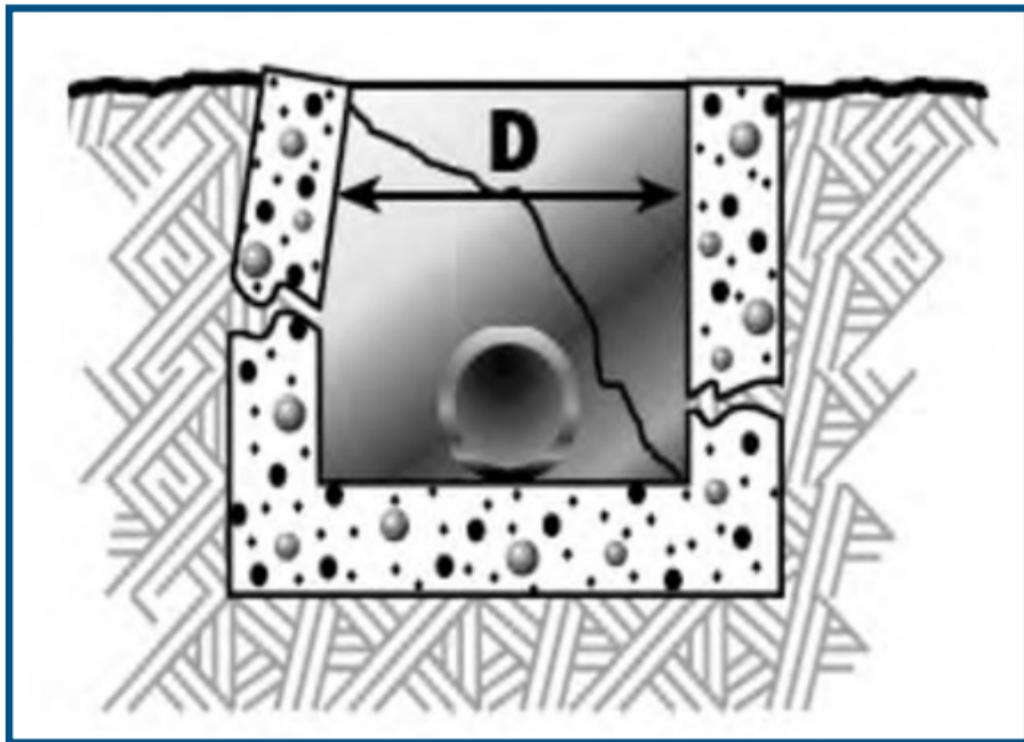
Figure 45 – Failure of a concrete outfall structure.

- Excessive side pressures on a non-reinforced concrete structure or poor concrete quality can cause failure of the outfall structure.
- The embankment may be exposed to erosion by outlet releases because of loss of an outfall structure.
- Too steep of a slope can cause rocks to roll down the hill and partially block the outlet, which reduces the flows that can occur through the pipe.

- Have a qualified engineer inspect the situation and recommend corrective actions. The corrective actions may involve improving drainage and water pressure relief at the structure, as well as structure repair or replacement.
- Repair the slopes and place riprap to stabilize them, where applicable.
- Keep outlet free of blockages.

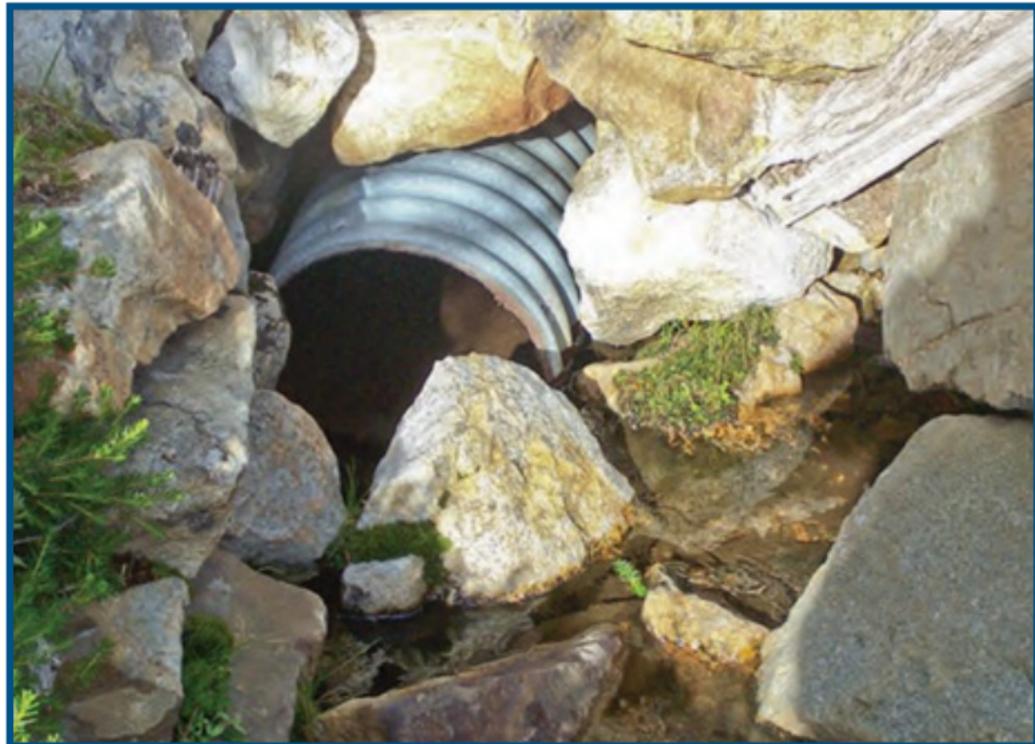
Figure 46 – Rock blocking discharge of an outlet

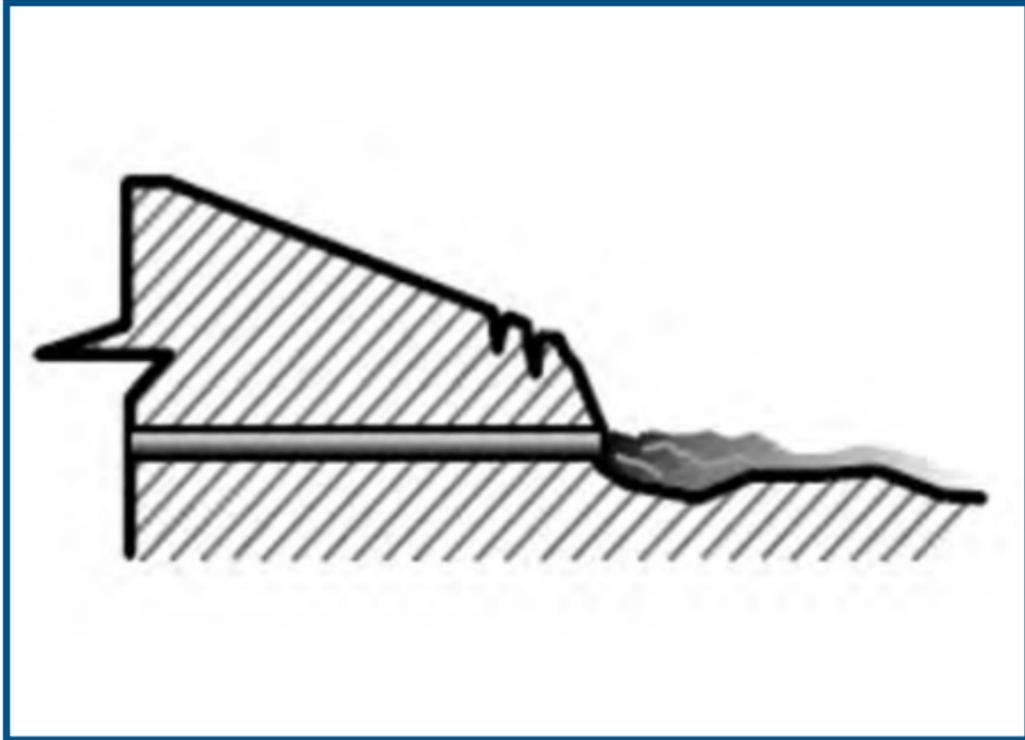
Figure 47 – Outlet releases erode the toe of the dam.

- The outlet pipe may be too short and result in scour at discharge end.
- No energy-dissipating pool or structure at the downstream end of the conduit can result in scour damage.
- Erosion of the toe of the dam makes the downstream slope too steep and may cause progressive sloughing.

- Extend the outlet pipe beyond the toe (use the same size of pipe and material). Form a watertight connection to the existing conduit.
- Stabilize the slope.
- Use riprap over suitable bedding to protect the embankment.
- Construct a stilling basin or energy-dissipating pool.
- Involve a qualified engineer if the remedy is not obvious.

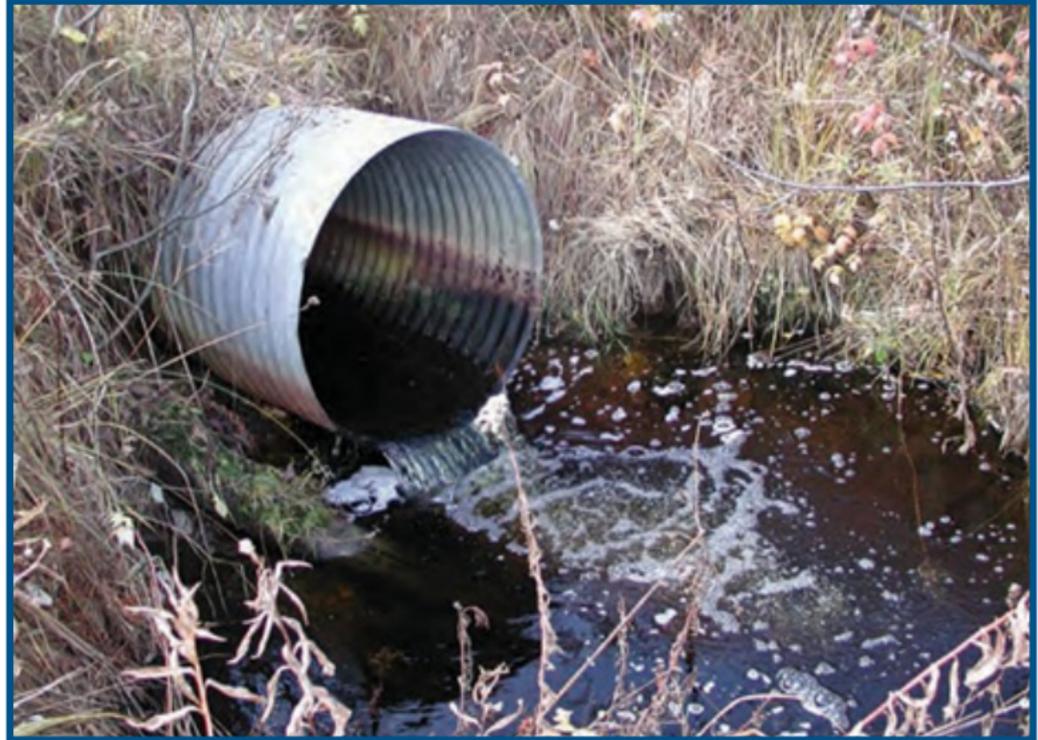
Figure 48 – A scour hole at an outlet resulting in erosion of the toe of the slope.

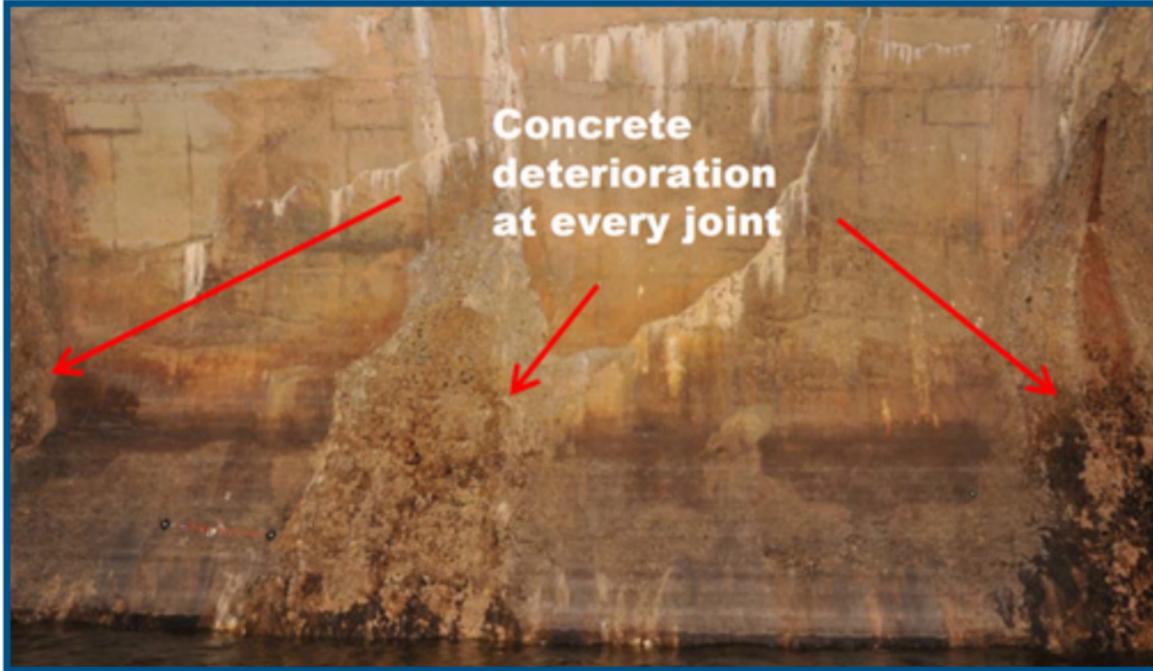
Figure 49 – Concrete deterioration, leakage and staining.

- Structural cracking (longer cracks, not pattern cracks), broken masonry, opening/closing or offsets at joints, and apparent deformation in structures can be indications of foundation problems.
- Foundation problems are the leading cause of concrete and masonry dam failures.
- Failures of concrete and masonry dams typically are sudden failures that can have catastrophic consequences due to their suddenness.

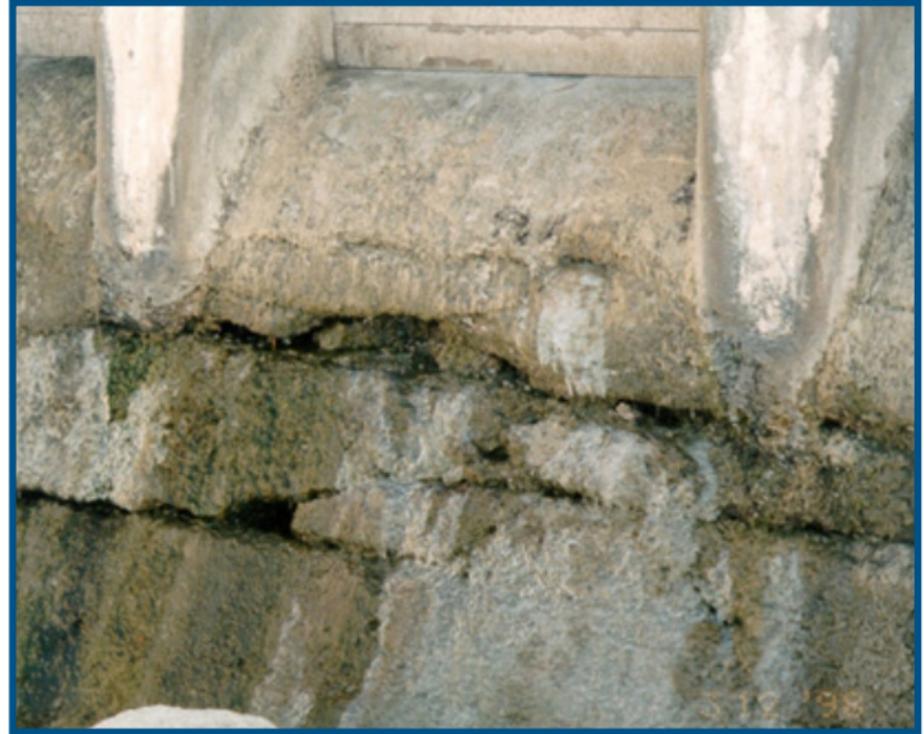
Figure 50 – Open joints.

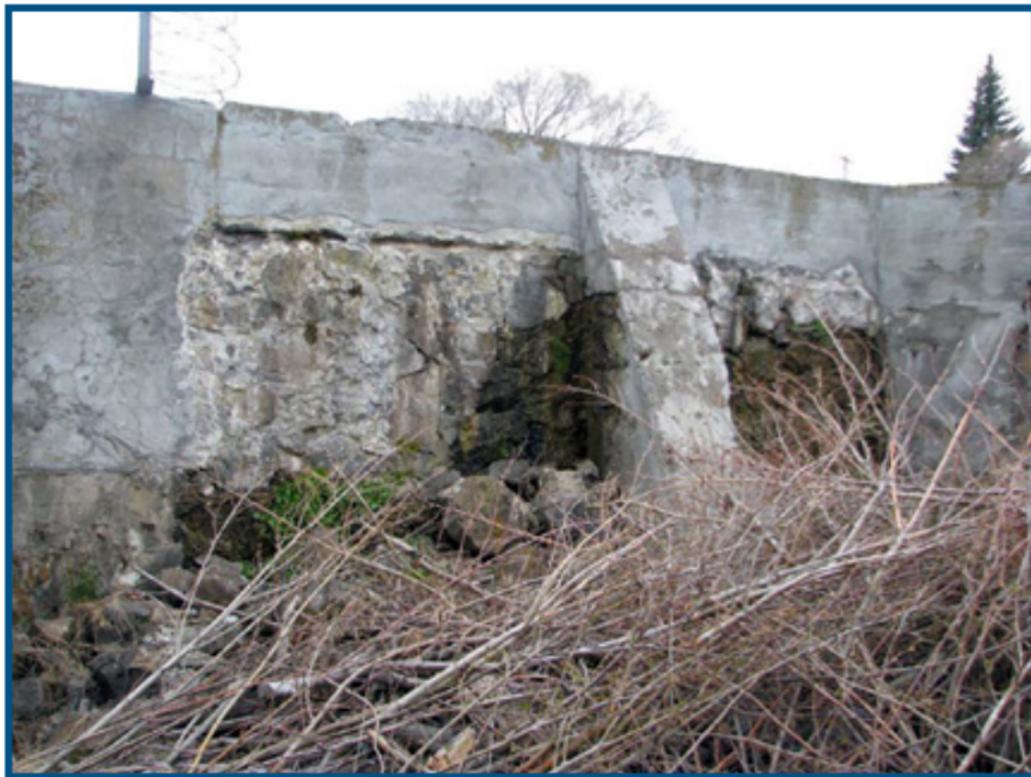
Figure 51 – Concrete deterioration on the downstream face of a dam.

- Deteriorated concrete or masonry materials may have less strength, and therefore less ability to carry the reservoir loads imposed on the dam.
- Failures of concrete and masonry dams typically are sudden failures that can have catastrophic consequences due to their suddenness.

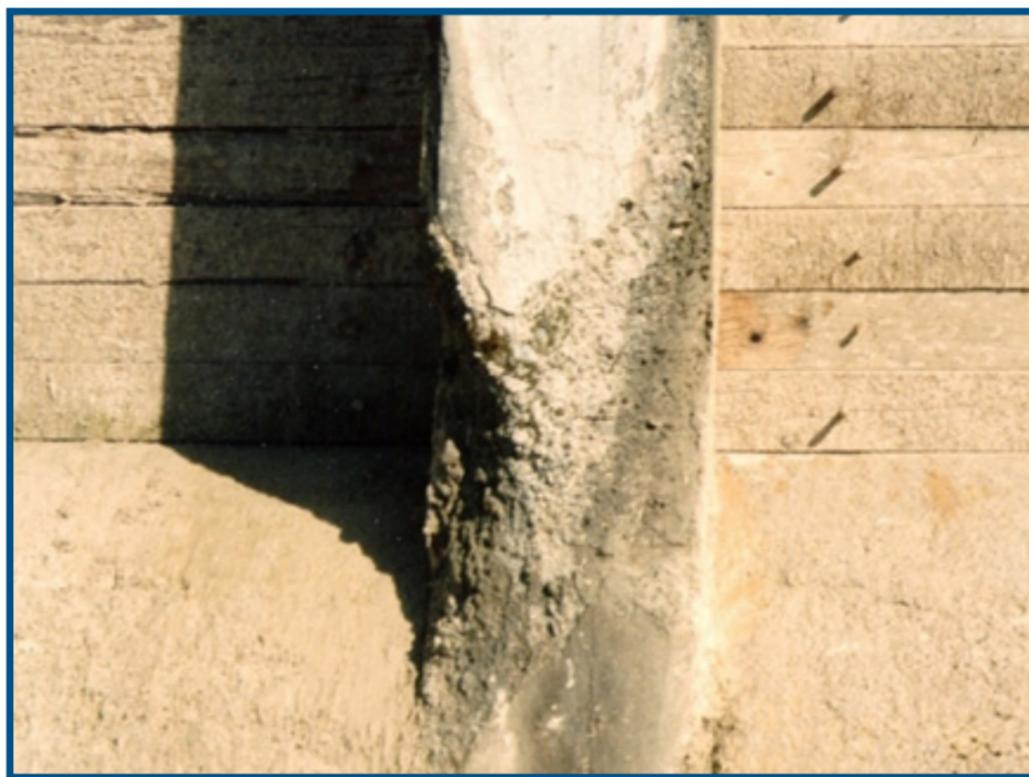
Figure 52 – Deterioration of a concrete pier.

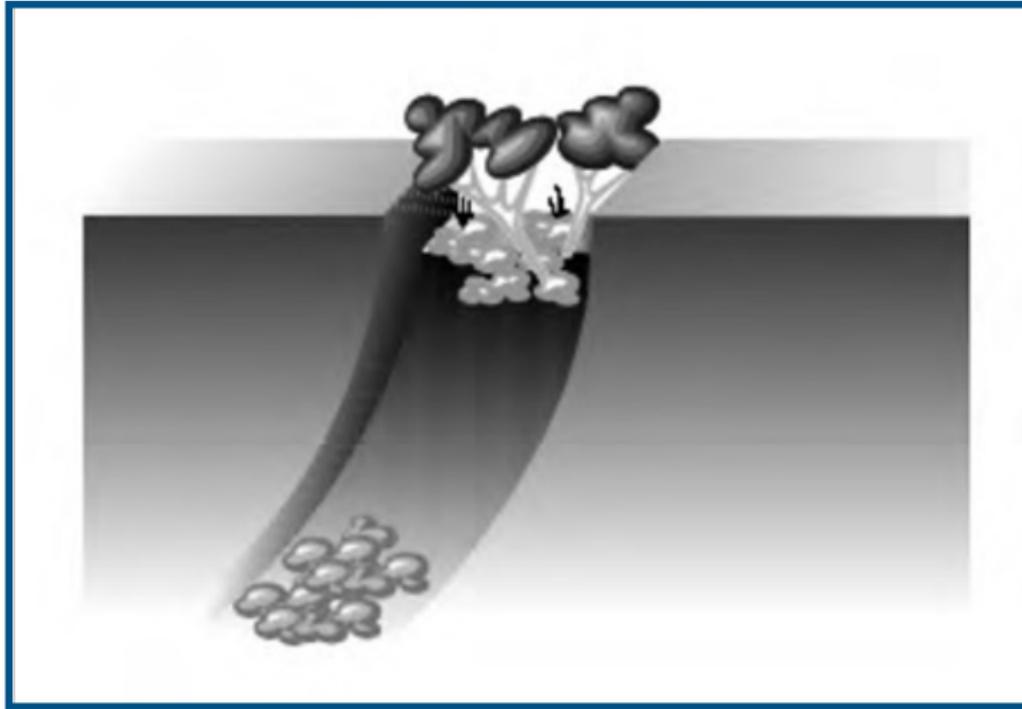
Figure 53 – Excessive vegetation or debris in a spillway channel.

- An accumulation of slide materials, dead trees, debris, excessive vegetative growth, etc., in the spillway channel can reduce waterway capacity.
- Reduced discharge capacity may cause the dam to overtop. Prolonged overtopping can cause dam failure.

- Clean out debris regularly as necessary to maintain an open waterway and control vegetative growth in the spillway channel.
- Install a log boom in front of the spillway entrance to intercept debris.
