Pocket Safety Guide for Dams and Impoundments

FEMA P-911 / October 2016

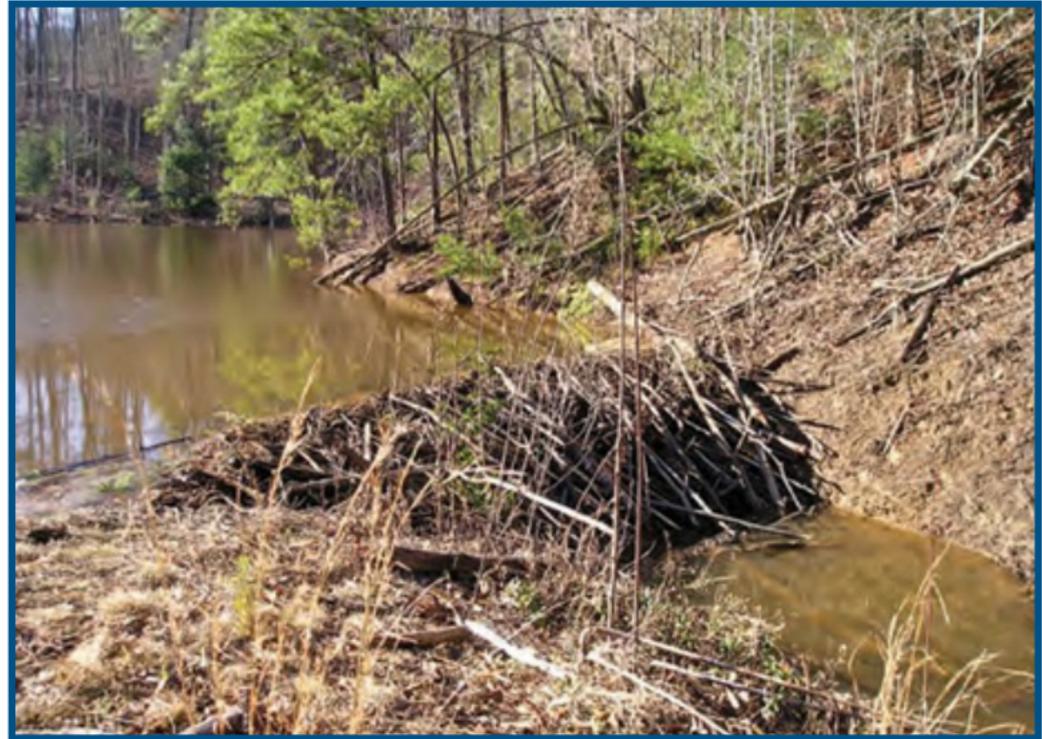
Figure 54 – A blocked spillway channel may cause overtopping of the dam due to the loss of the spillway discharge capability.

- An accumulation of slide materials, dead trees, debris, excessive vegetative growth, etc., in the spillway channel can reduce waterway capacity.
- Reduced discharge capacity may cause the dam to overtop. Prolonged overtopping can cause dam failure.

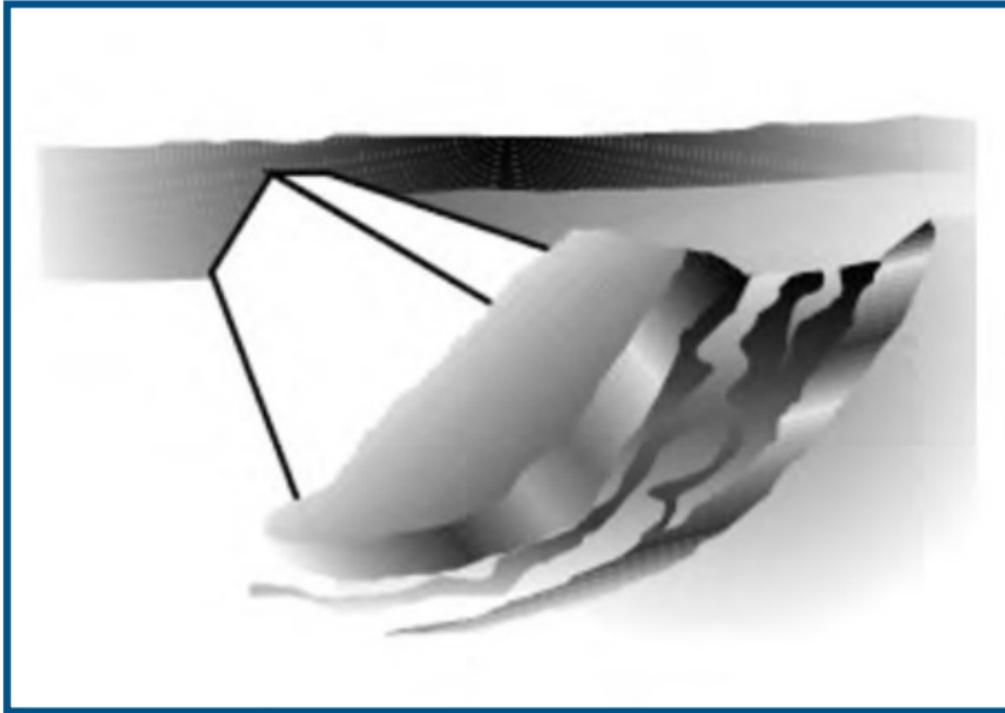
Figure 55 – Erosion channels.

- Surface runoff from intense rainstorms or flow through the spillway erodes spillway flow surfaces.
- Livestock traffic creates gullies where runoff flow can concentrate and cause erosion.
- Irregularities in concrete structure flow surfaces can lead to damage and loss of structure due to cavitation, stagnation pressures, etc.
- Unabated erosion can result in headcutting, erosional spillway failure, and unintended, uncontrolled, large releases at the spillway location.
- Spillway damage can result in reduced spillway capacity. Inadequate spillway capacity can lead to embankment overtopping and result in dam failure.

- Have a qualified engineer inspect the conditions and recommend remedial actions.
- Photograph the condition.
- Replace eroded material with compacted fill to repair damaged areas, if appropriate.
- Revegetate the areas if appropriate.
- Install suitable rock riprap to protect against future erosion., if appropriate.
- Closely monitor spillway performance during flood events.

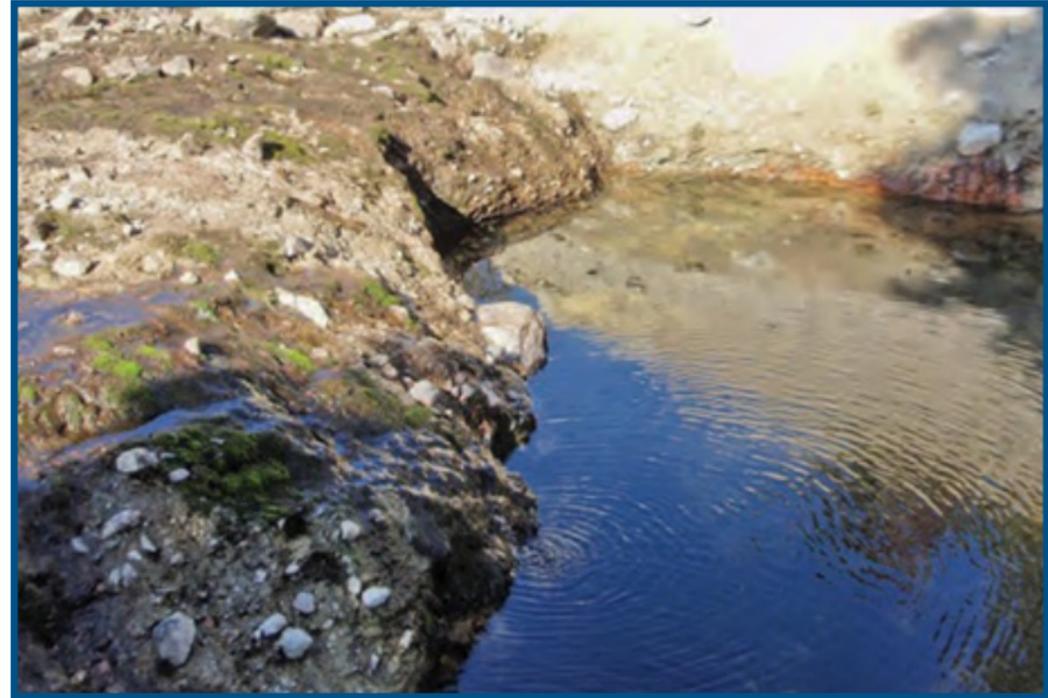
Figure 56 – Erosion of the spillway channel may lead to slumps or slides of the spillway sides, or large, uncontrolled, unintended releases in the event erosional headcutting in the spillway channel breaches the spillway crest.
